Homescape Inspections

Report #: LAJ 10-18-22 Inspector: Kevin Brenden

Date of Inspection: 10/18/2022

Dwelling Address: 79 Port of Spain
Coronado, CA 92118

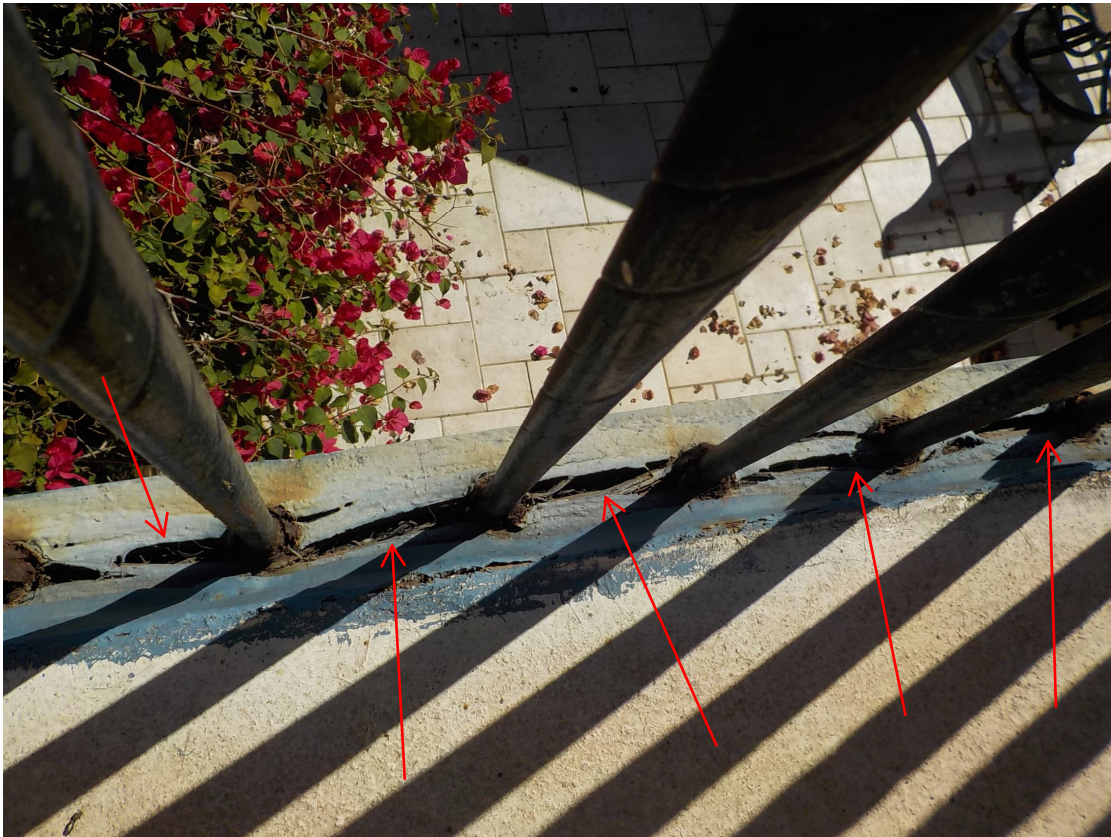
04

Repairs Recommended. Location(s):+Rear of home; Material:+Waterproof coating; Railing:+deteriorated (2) (4). Recommend further evaluation and repairs as needed by a qualified professional. (2)

Railings are in need of repairs. (2)

Moisture damage noted to wood framing for railing at time of inspection. (2) (3)

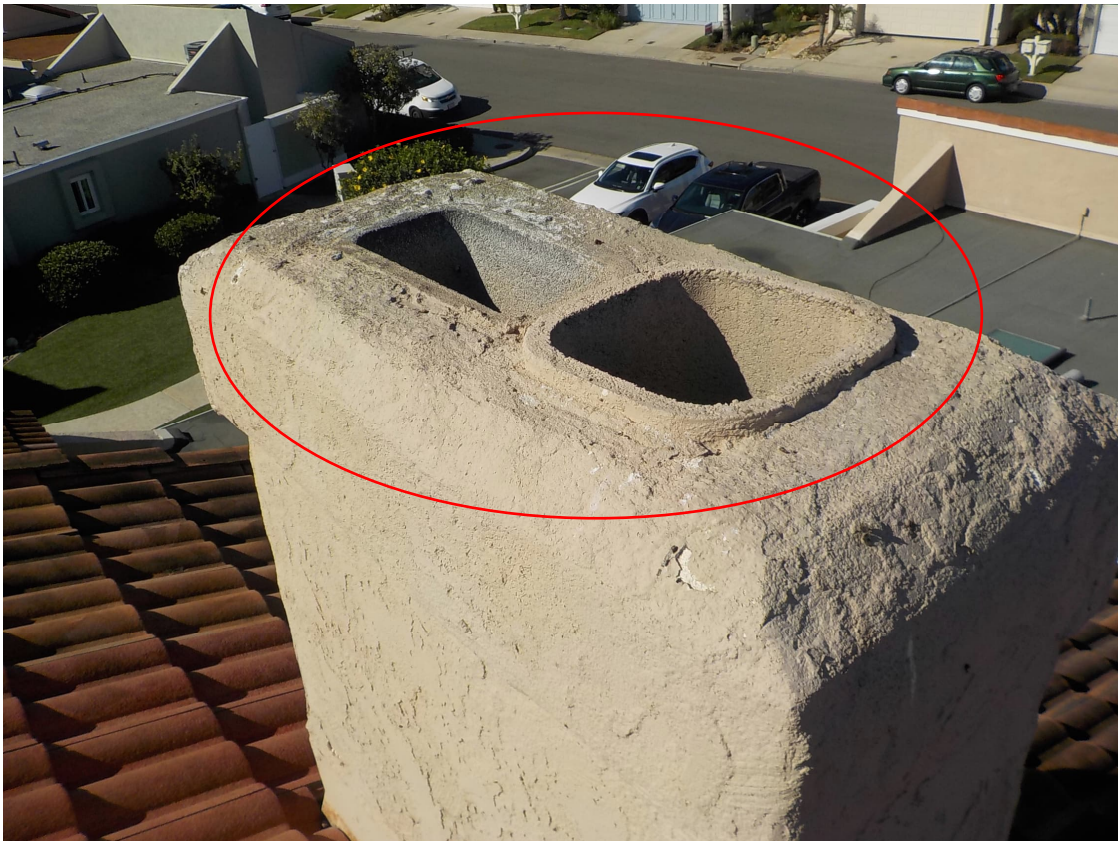
11 Chimney(s) **Repairs Recommended. Location:+Family Room; Material:+Brick. Recommend further evaluation and repairs of chimney assembly as needed by a qualified professional. (2)**

The chimney does not have a proper spark screen; recommend installation prior to using fireplace. (2) (4)

Recommend the installation of a rain cap with approved spark arrestor. *

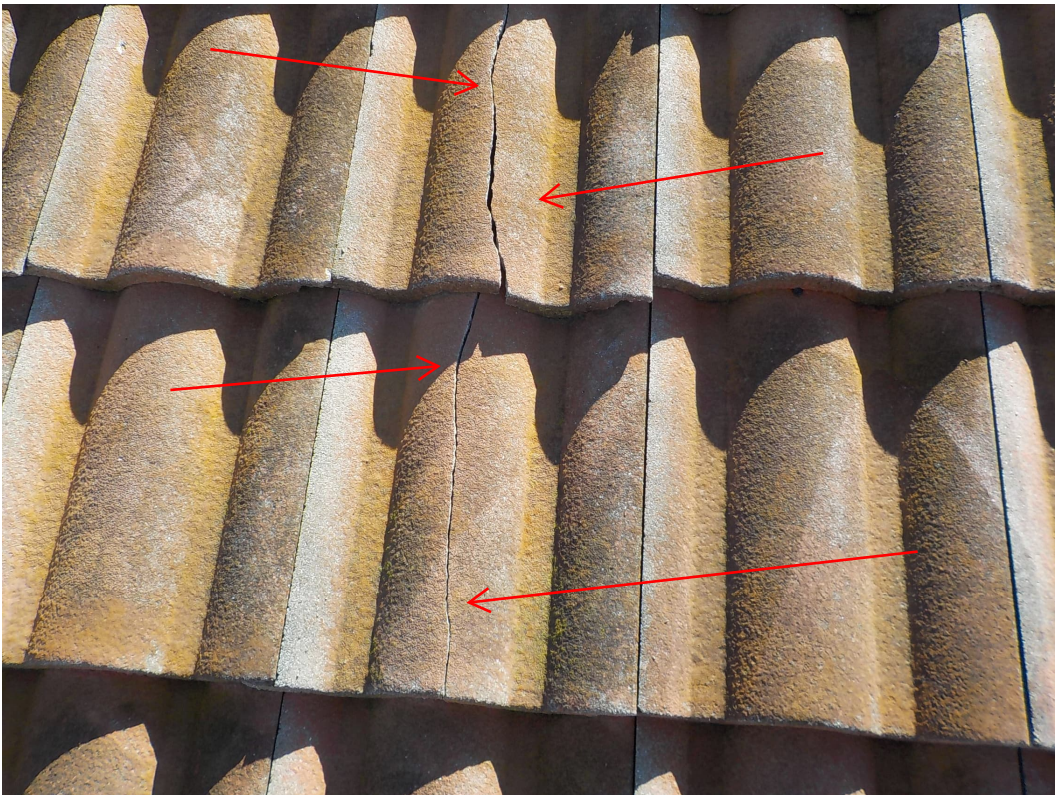
20a Tile Roof #2 **Repairs Recommended. Location:+Garage; Roof style:+Single Slope; Roof covering is:+concrete tile; Roof inspected by:+walking roof. Recommend further evaluation of roofing system and repairs by a qualified licensed roofing contractor. (2)**

The roofing underlayment appears to be In excess of 30 years old at the time of inspection. Licensed roofing contractors recommend removing tile and replacing the underlayment every 30 years at the most. The underlayment will become old and brittle after 30 years and no longer provide the water proofing that is recommended. (2)

Moss covering portions of the roof; this condition can accelerate the wear and deterioration of the roof. (2)

The roof covering had cracked tiles at the time of the inspection. (2)

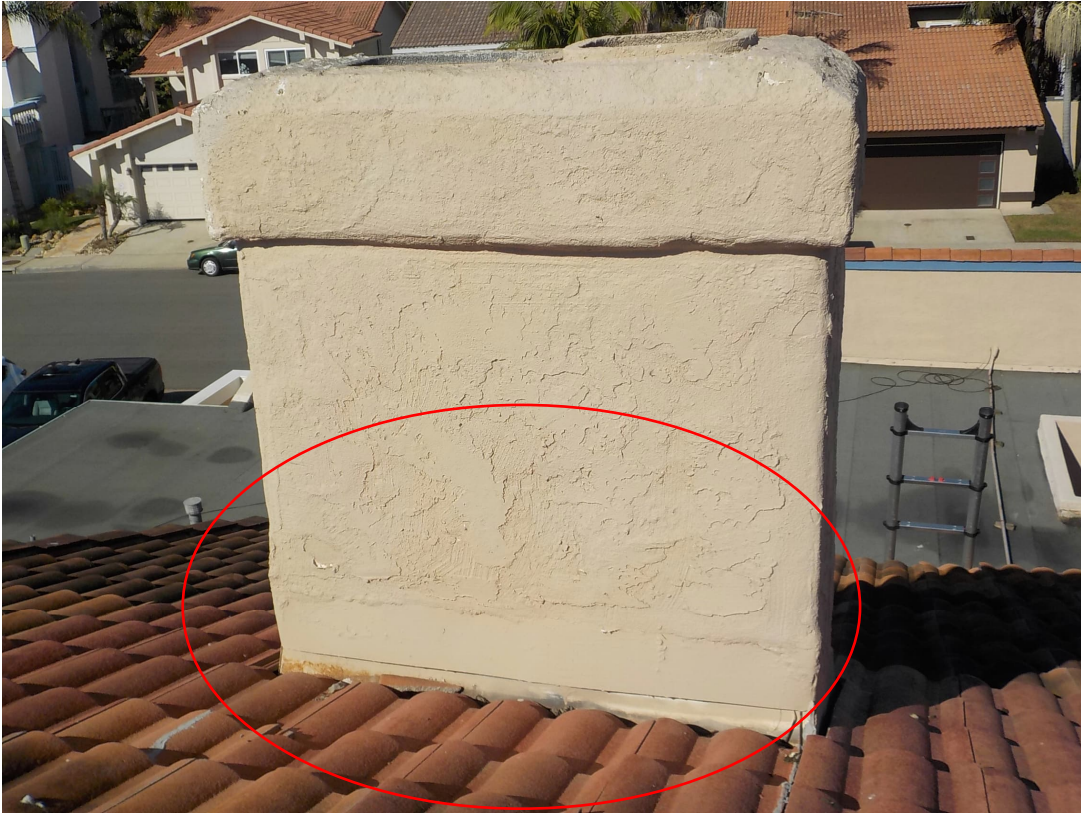
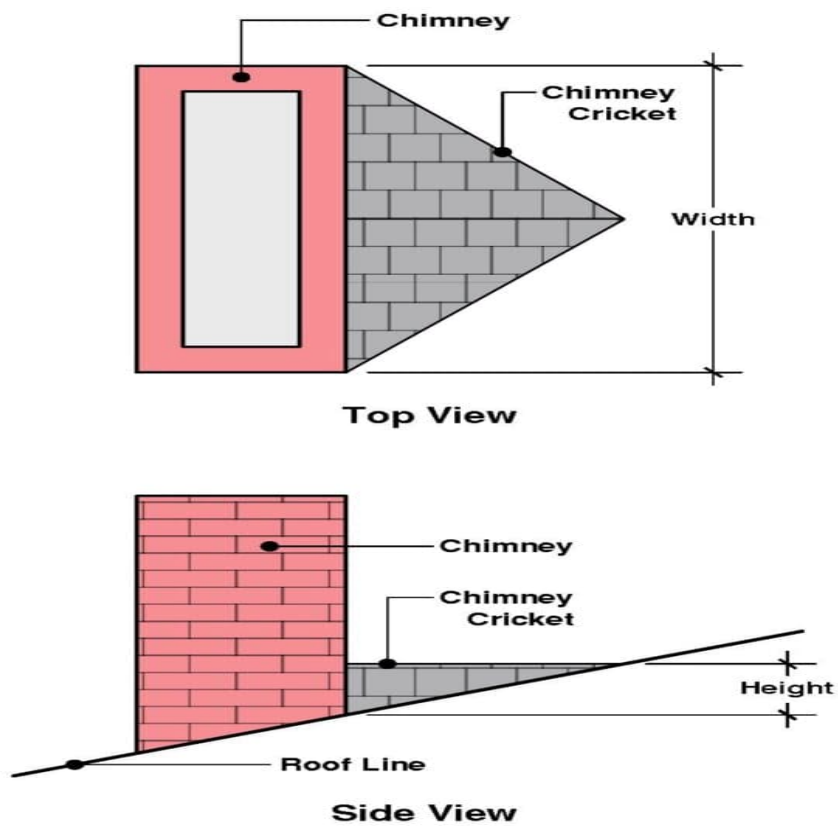
Repairs Recommended. Vent caps appear serviceable; Skylights appear serviceable. Conditions were noted at the flashings that warrant additional evaluation and repairs by a licensed roofing contractor. (2)

Separations noted in the exposed flashing at the furnace vent. (2)

The exposed ABS plumbing vents at the roof area were not painted. Paint is required at the exposed ABS vents. We recommend having the exposed ABS vents painted by a qualified licensed contractor. (2)

Home is missing a properly installed Cricket/slopped roofing at the rear of the chimney. A cricket is a secondary roof built on top of an existing roof designed to divert water drainage away from vertical protrusions. (2)

Based on this code section we can see that the chimney will require a cricket when the width is greater than 30 inches.

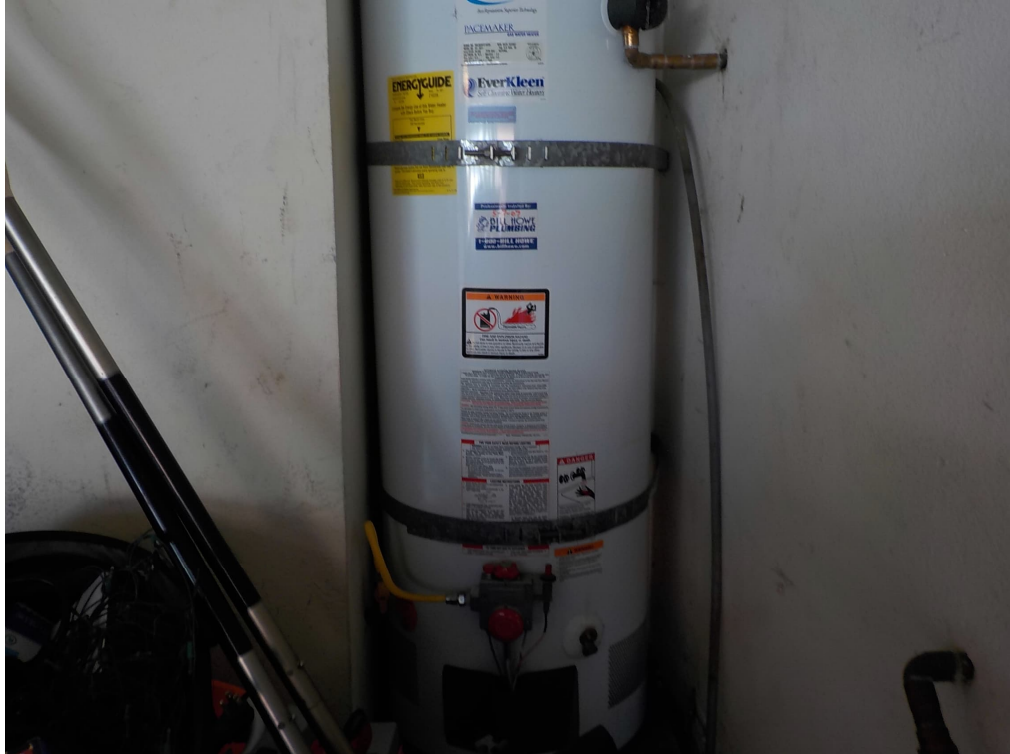
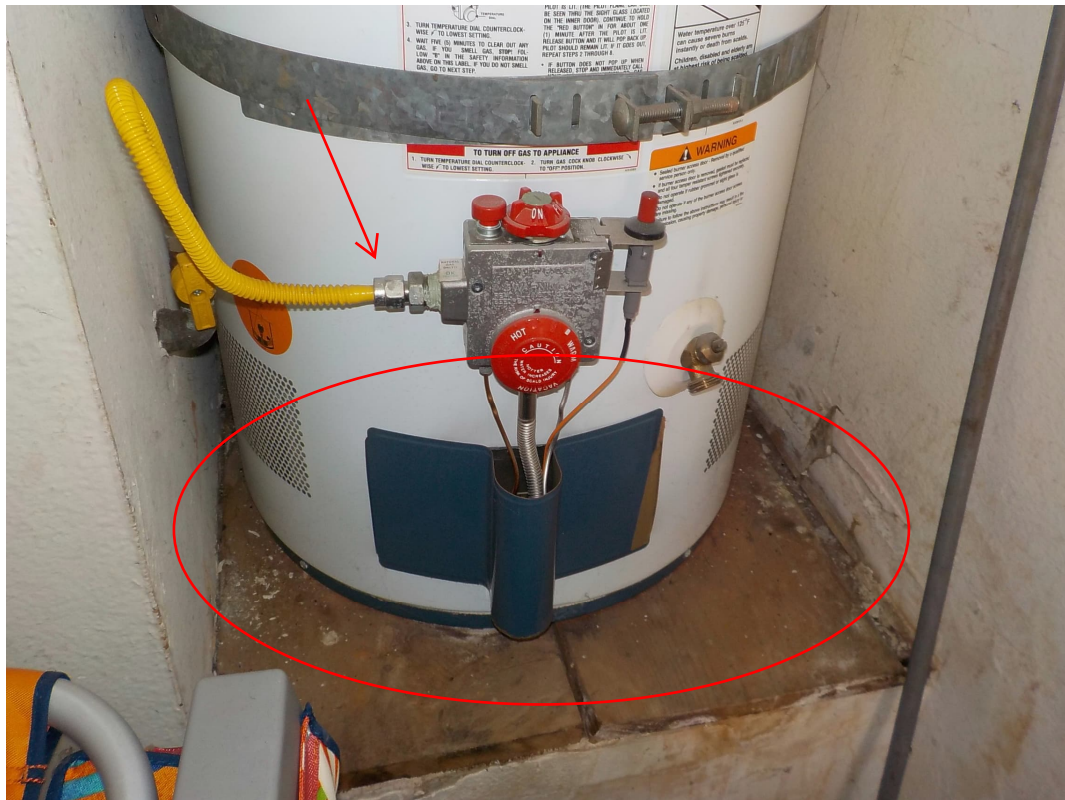
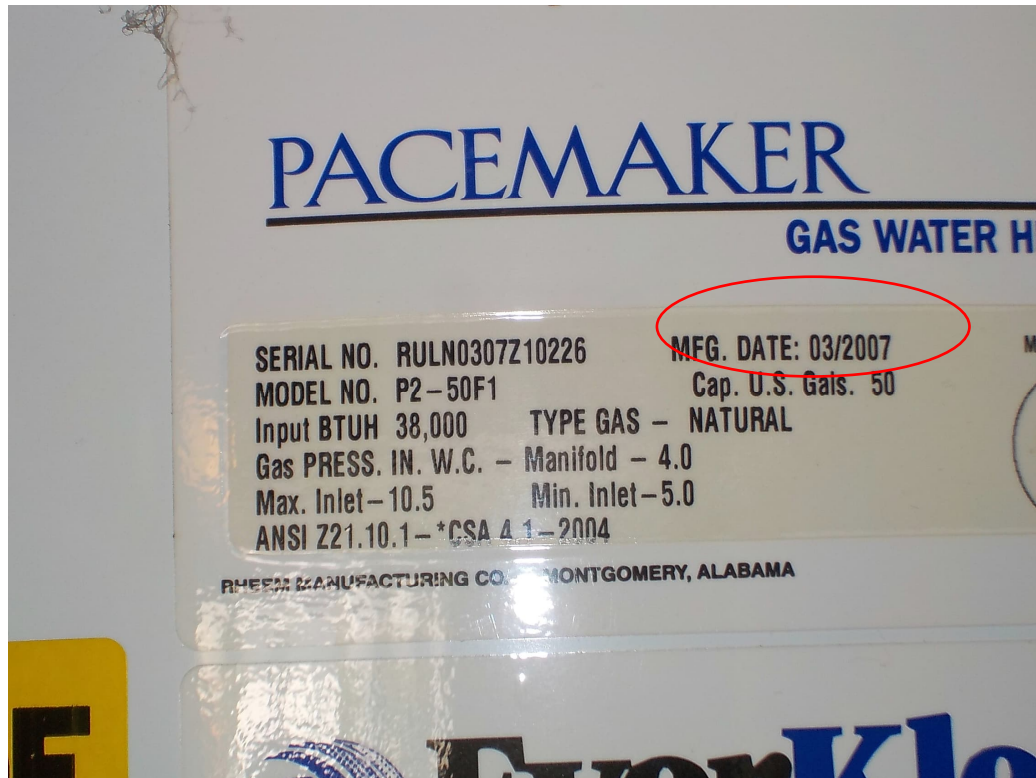
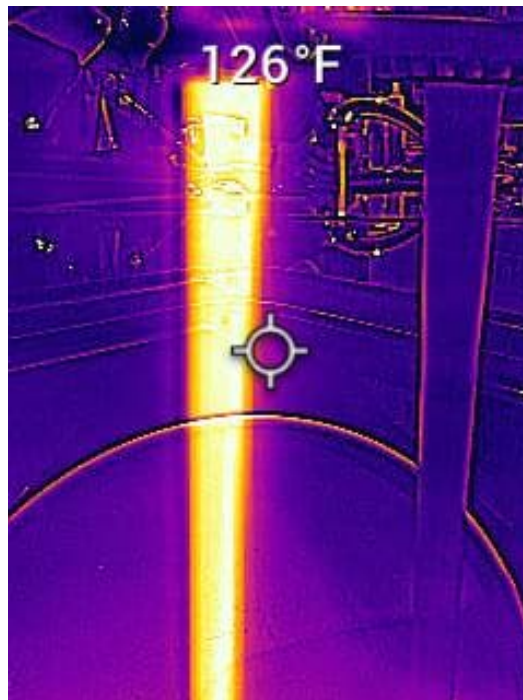
27

**Repairs Recommended. Location:+Garage;
Type:+Conventional Natural Gas; Capacity:+50 gal.; Water shut off installed:+Yes; TPR valve installed:+Yes; TPR discharge pipe properly installed:+Yes; Vent flue piping:+Appears Serviceable; Combustion air:+appears serviceable; Seismic straps:+Appears Serviceable. Recommend further evaluation and repairs by a qualified professional (Licensed Plumber). (2)**

Hot water heater gas line is not equipped with sediment trap. Upgrade - A sediment trap or drip leg was not installed before the gas appliance shutoff valve. This is a simple pipe assembly made of a tee and nipple that catches moisture and debris in the gas. Debris can clog the gas valve causing the appliance to malfunction. This device is required by all manufactures of water heaters and furnaces or any gas appliance that has automatic ignition. Missing on the water heater. Recommend installation by qualified contractor. (2)

Inspector tested water temp utilizing FLIR Infrared camera and water temp tested at 126 degrees Fahrenheit which is outside the safe operating temperature to prevent scalding. Recommended setting to prevent scalding is at 120 degrees or less. Inspector recommends further evaluation by a qualified/licensed plumber. (2)

System is an older unit (2007) and the life expectancy on water heaters of this type is approximately 10-12 years. Determining the future performance of the system is beyond the scope of this inspection. System could require repairs and/or replacement at any time. (2)

The water heater should have a catch pan with a properly sized drain line extended to the exterior of the home. (2)

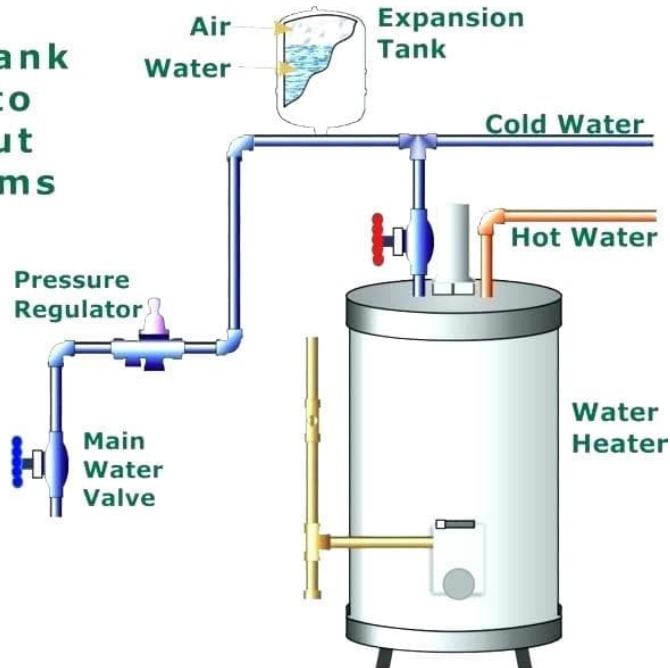
An Expansion Tank allows water to expand without causing problems

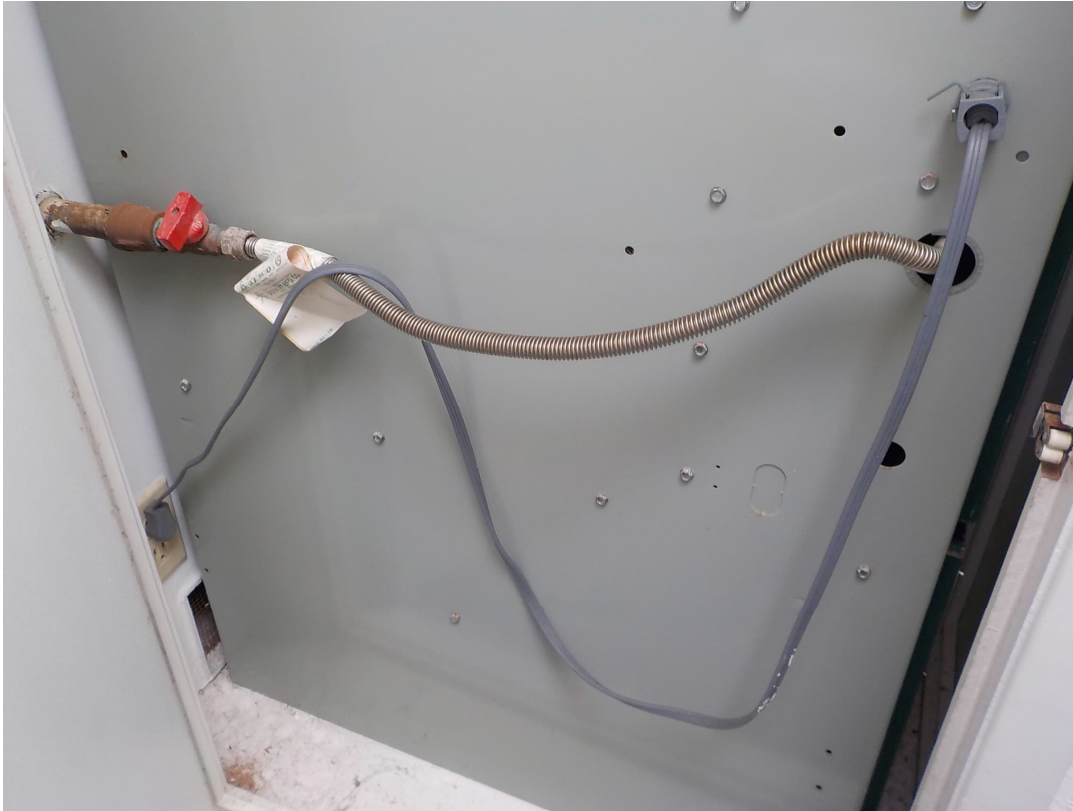
Repairs Recommended. Maintenance recommended (2). System does not appear to have been serviced per manufacturer's instructions within the last year. (2)

Flexible gas tubing has been installed through the appliance exterior housing. Per Mfr Installation Instructions and current building codes this installation is not permitted and is considered a safety hazard. Recommend repairs be completed by qualified professional contractor by installing rigid gas piping through appliance housing to gas valve in appliance.(2)(5)

Furnace gas line is not equipped with sediment trap. Upgrade - A sediment trap or drip leg was not installed before the gas appliance shutoff valve. This is a simple pipe assembly made of a tee and nipple that catches moisture and debris in the gas. Debris can clog the gas valve causing the appliance to malfunction. This device is required by all manufactures of water heaters and furnaces or any gas appliance that has automatic ignition. Recommend installation by qualified contractor. (2)

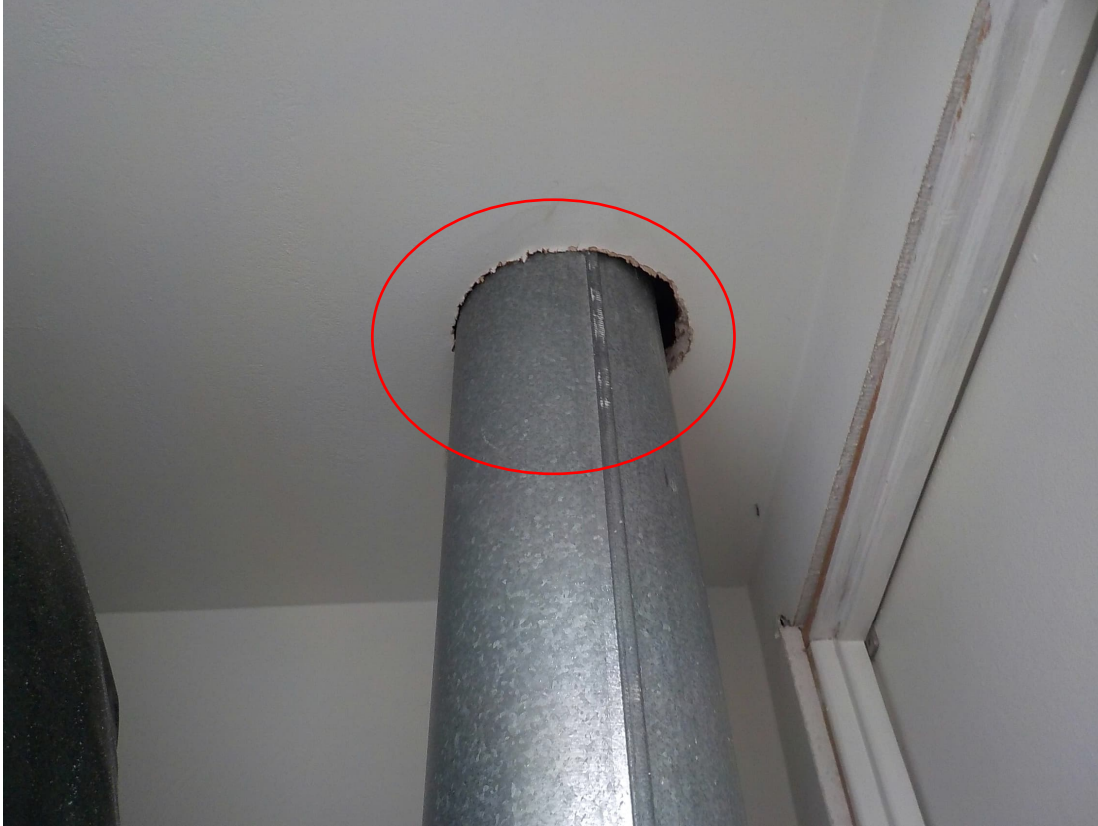
30 Venting

Repairs Recommended. Recommend further evaluation and repairs by a licensed HVAC contractor. (2)

Furnace vent lacks proper clearance from combustibile materials. (2) (4)

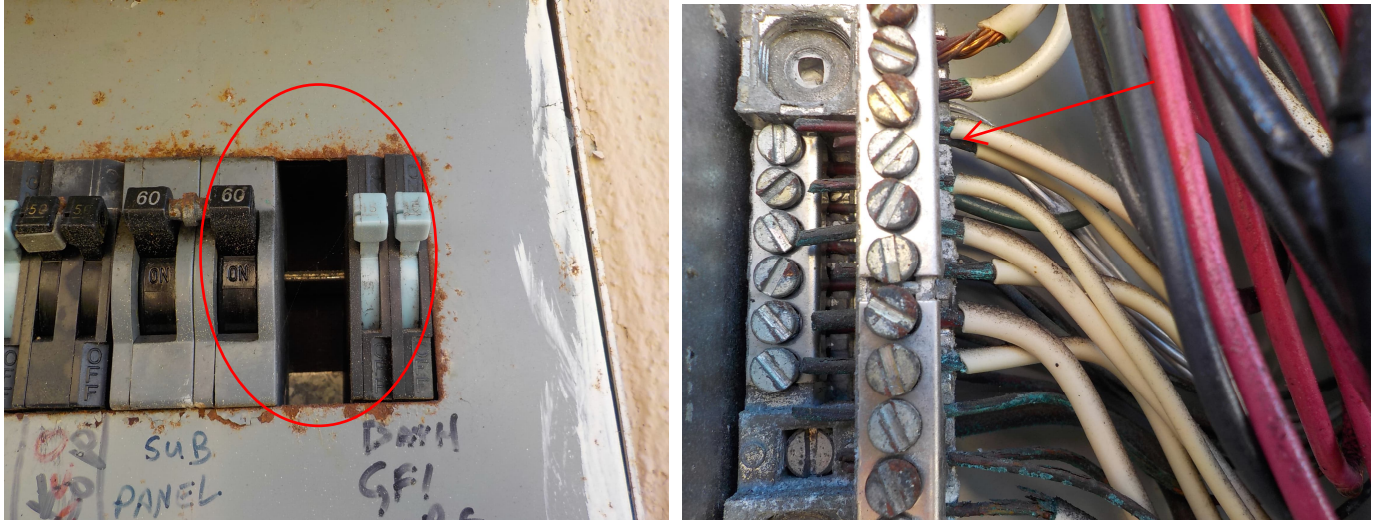
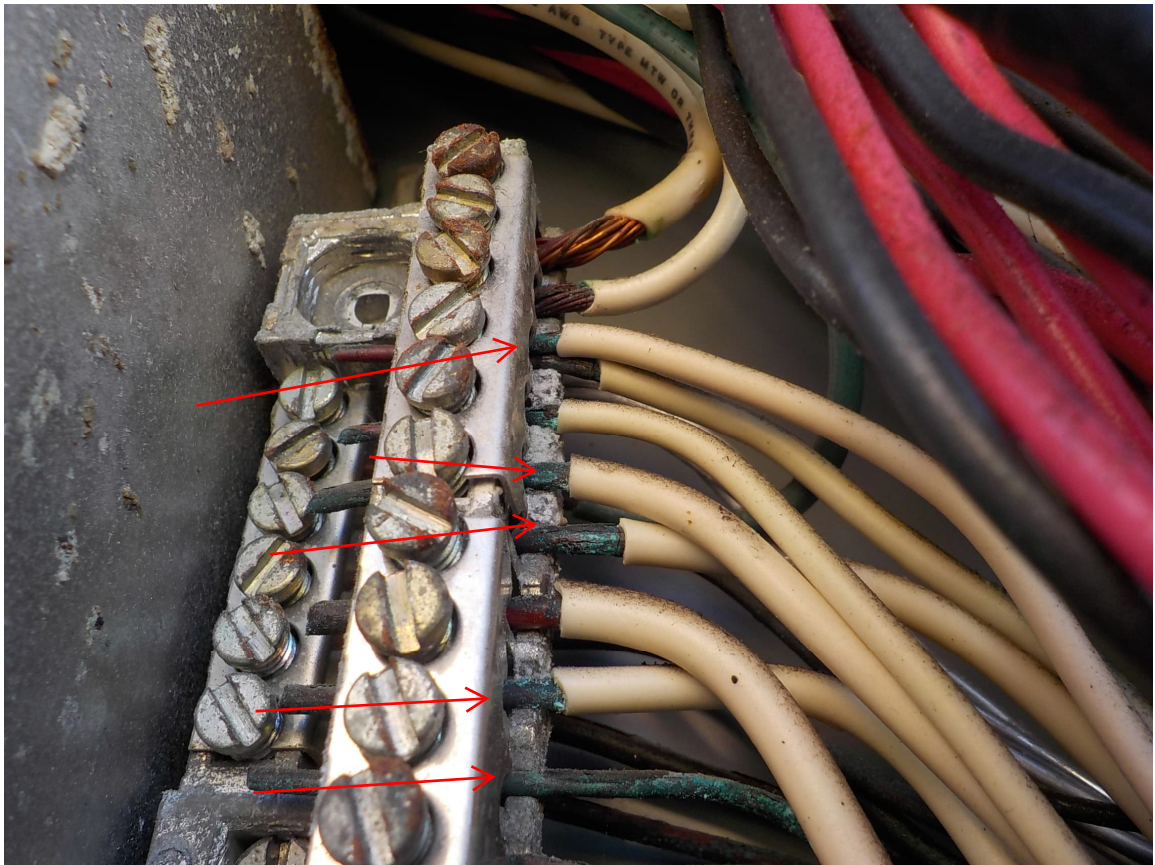
Rust/corrosion noted in the main electric panel. Rust can cause breakers to become unreliable or cause poor connections. This is common in homes in this region, and breakers/panels need to be replaced more often due to the close proximity of the ocean. Advise further evaluation by a licensed electrician to determine if any repairs are needed at this time.

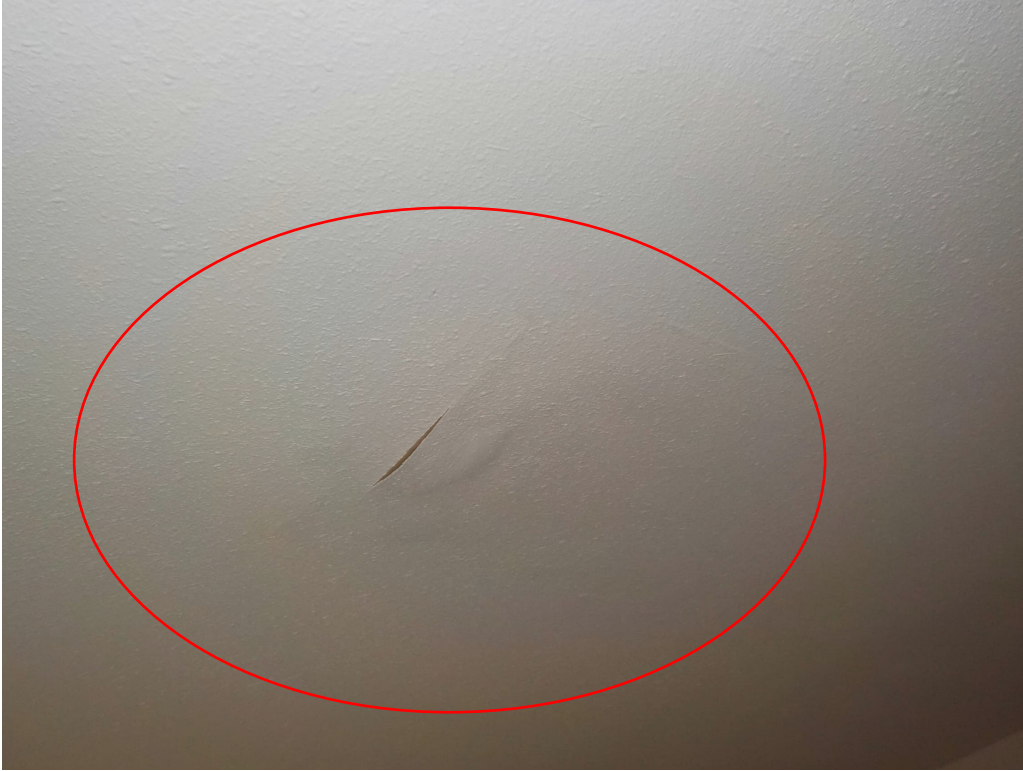
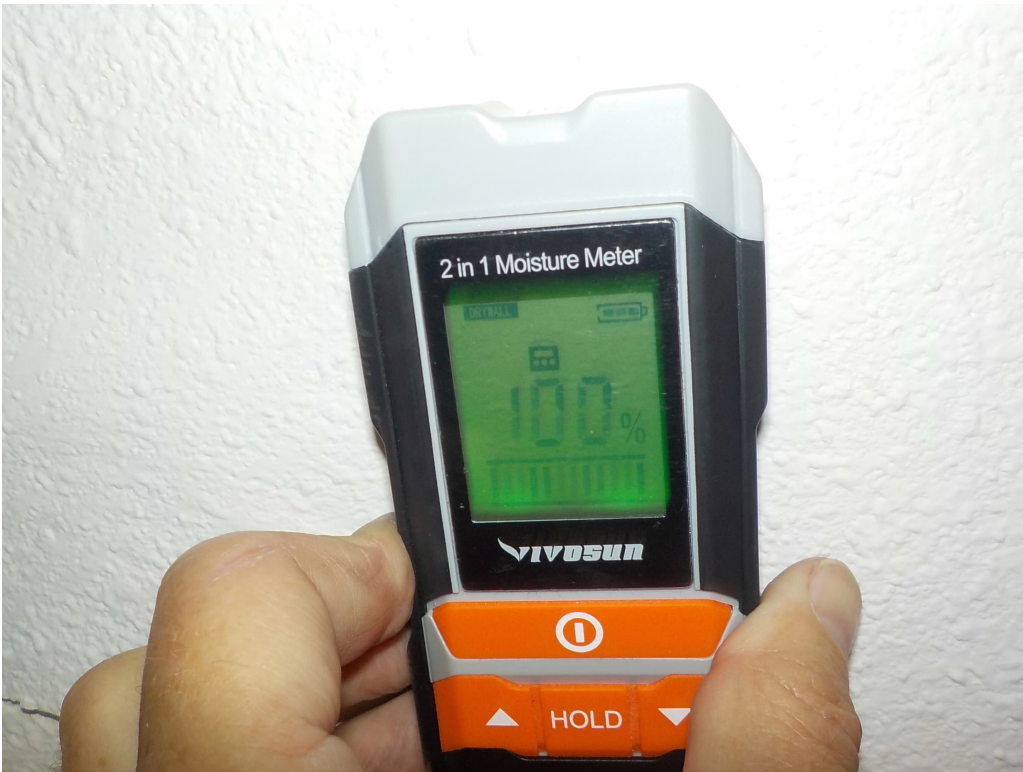
- 50 Ceilings **Repairs Recommended. Drywall. Recommend further evaluation and repairs as needed. (2)**

Moisture stains noted at exercise room. (2) (3)

Stains are moist; source unknown. Inspector tested area with moisture meter and area was wet, reading from moisture meter indicate that moisture levels range from 92%-100%. Recommend further evaluation and repairs as needed. (2) (3)

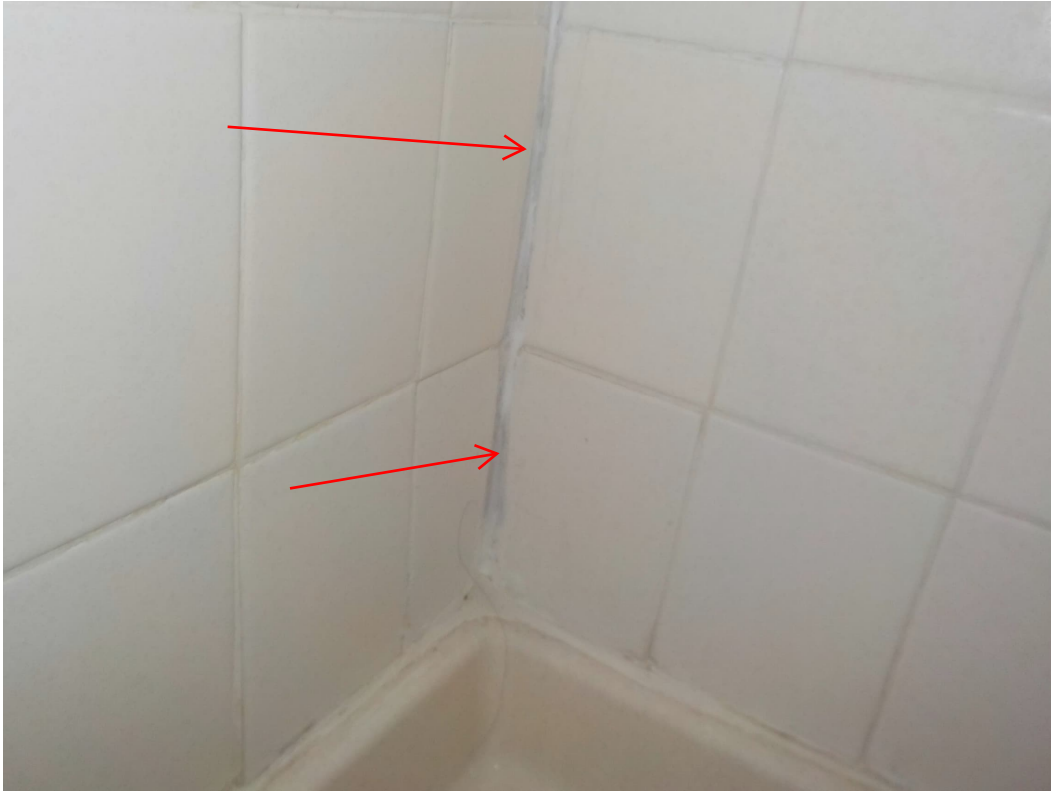
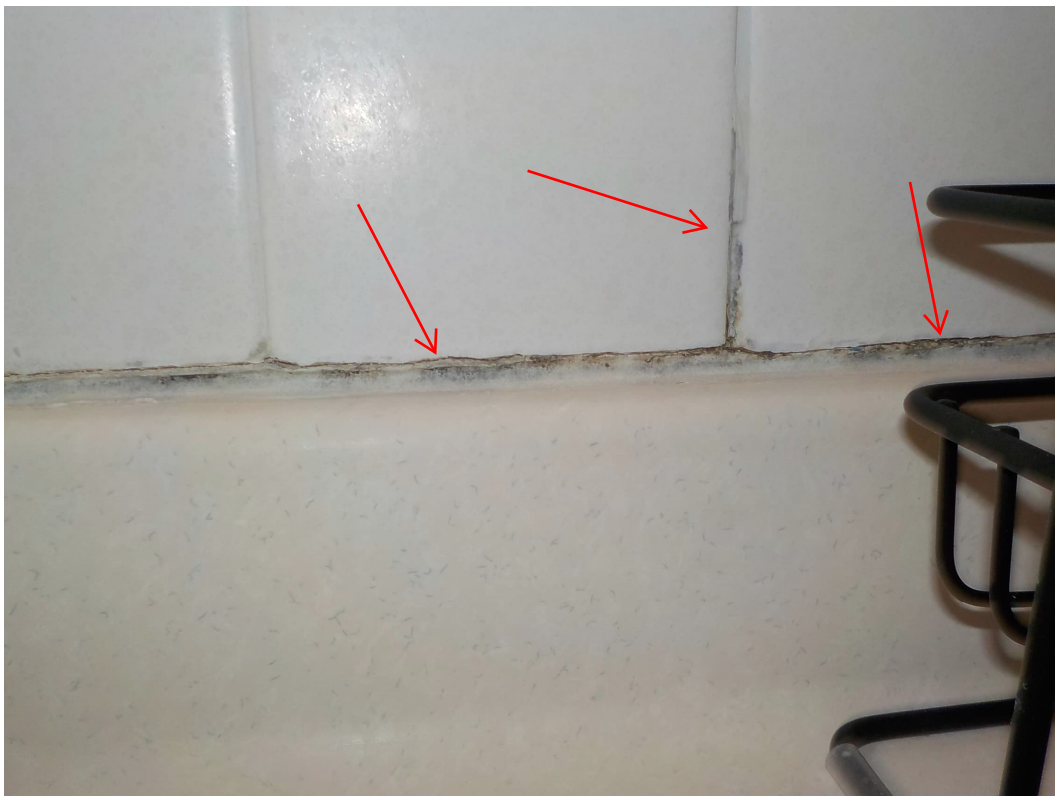
Caulking or grout needed at the shower walls in lower bathroom. * (3)

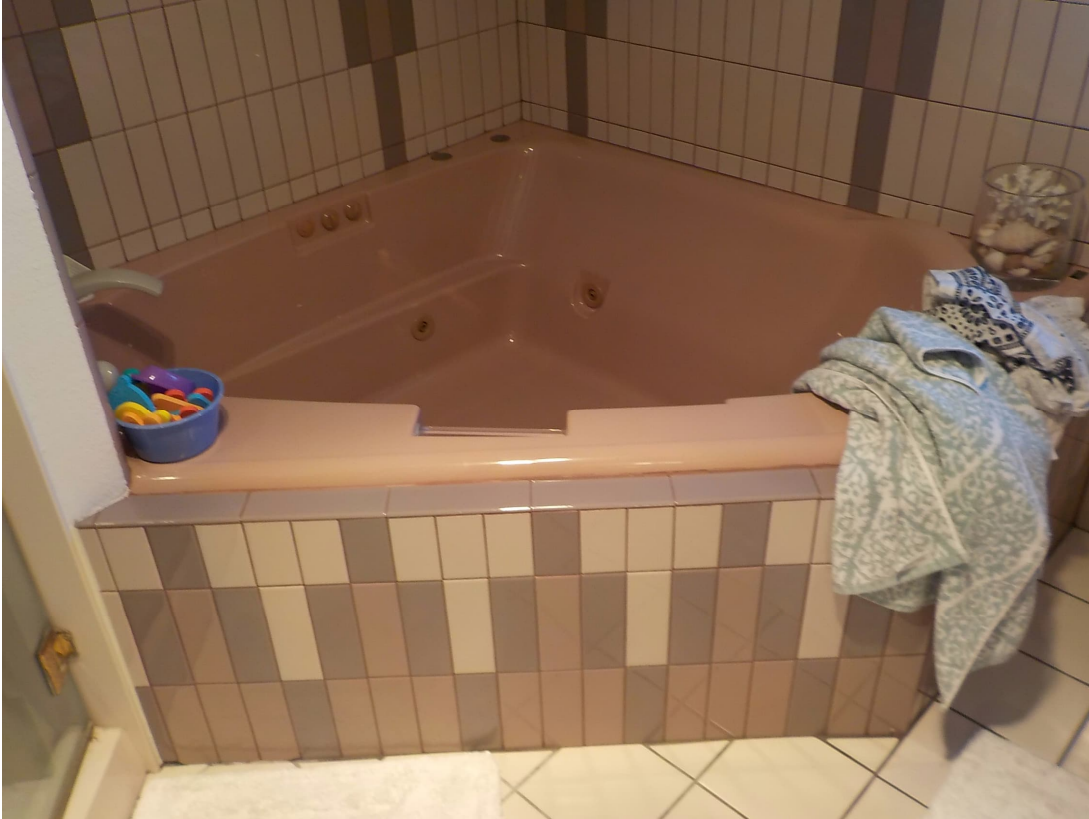
75.2 Bathtub **Repairs Recommended. Faucet appears serviceable; Drain appears serviceable; Hydromassage style tub:+present - not operational (2). Recommend further evaluation by a qualified professional (Licensed Plumber). (2)**

Hydromassage type tub was present, however, access panel to pump was corroded shut and not accessible. (2)
