PRP Inspections Inc.

SUMMARY REPORT

Client: Lee & Rob Harring
Inspection Address: 1905 Catalina Blvd, San Diego, CA 92107
Inspection Date: 7/18/2021 Start: 9:30 am End: 12:00 pm
Inspected by: Michael Durnell

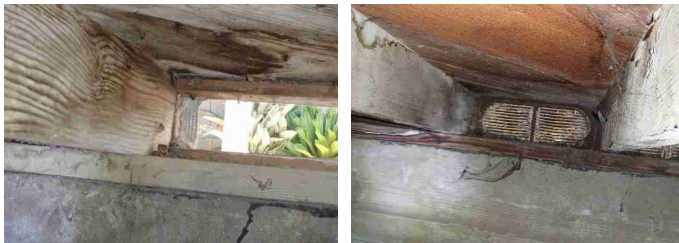
Raised Foundation Type

The foundation is raised and bolted to the standards of the year in which it was constructed, which may well be adequate but which would not meet current structural standards.

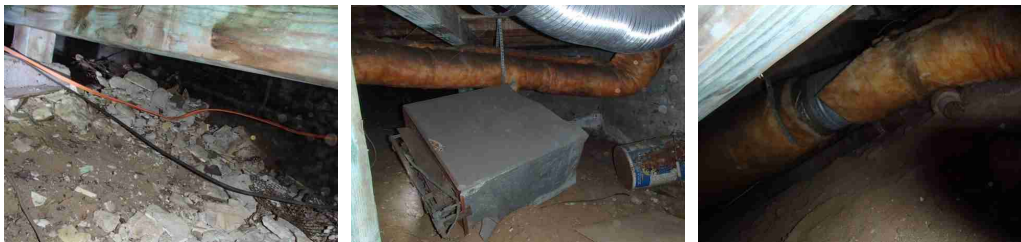
Crawlspace Observations

There is miscellaneous construction debris or other stored items which should be removed to prevent rodents from living under the home

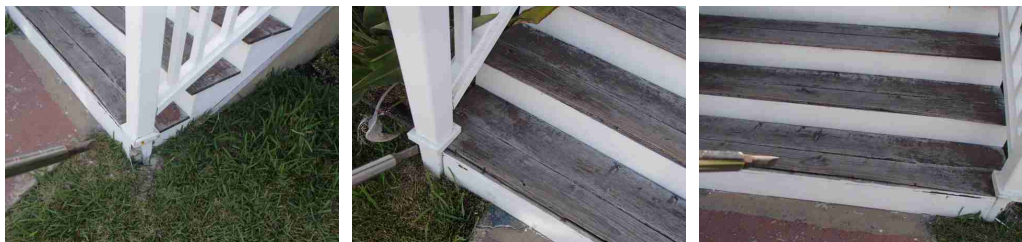
There is loose stairs and wood damage to the front stairs that should be evaluated by the termite inspector and or contractor for safety reasons.

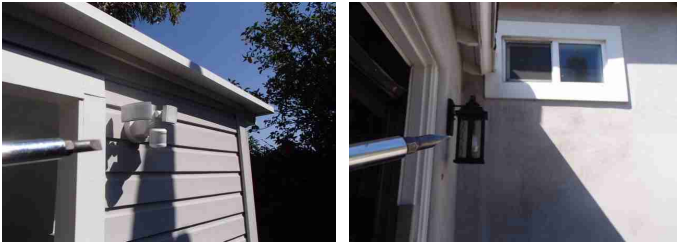
We were unable to test outdoor flood lights or security lights which may have photo sensors on them. Recommend sellers ensure the lights are functional.

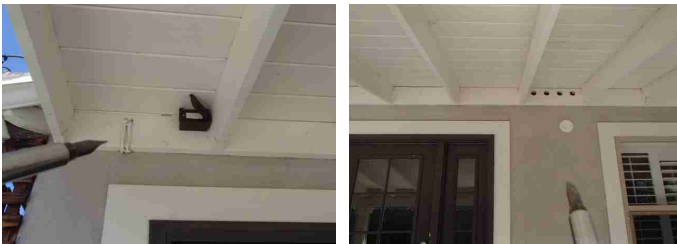
There are not lights under the back patio from either exit and some should be installed for safety reasons and a light source as you exit the home.

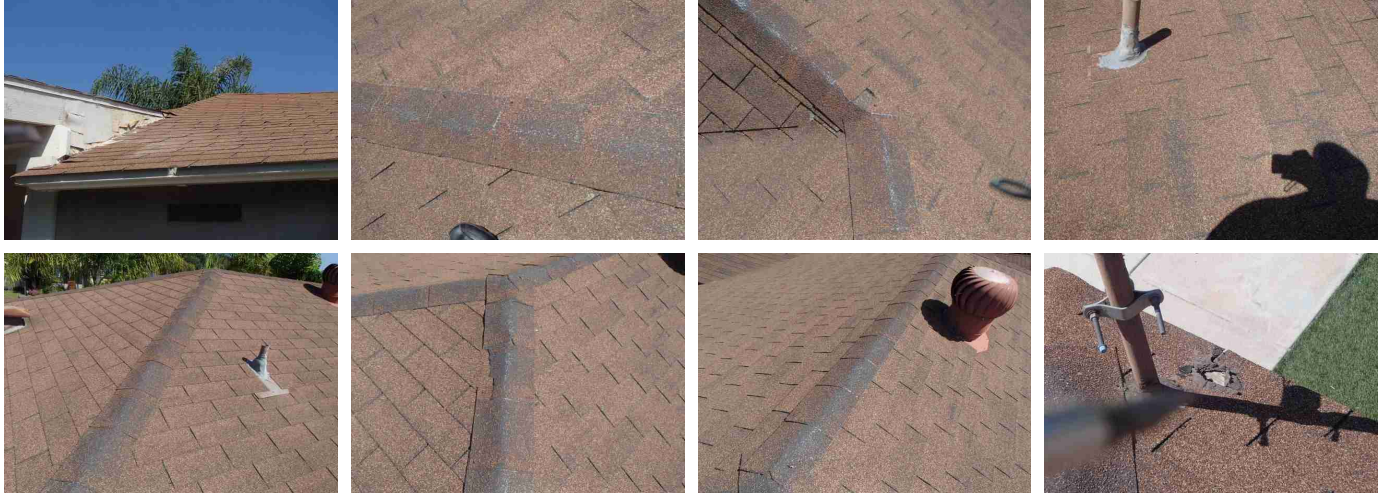
Sections of the roofing material is deteriorated and should be evaluated by a roofing contractor, because the cost of replacing the roof could significantly affect your evaluation of the property.

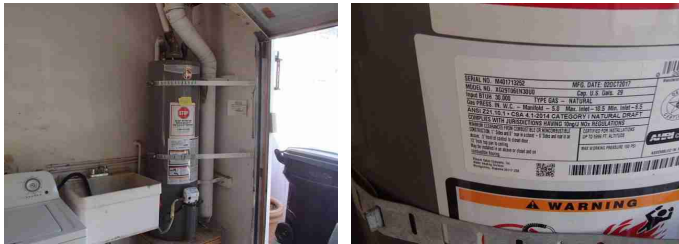
Hot water is provided by a 4 year, 29 gallon water heater that is located in the garage.

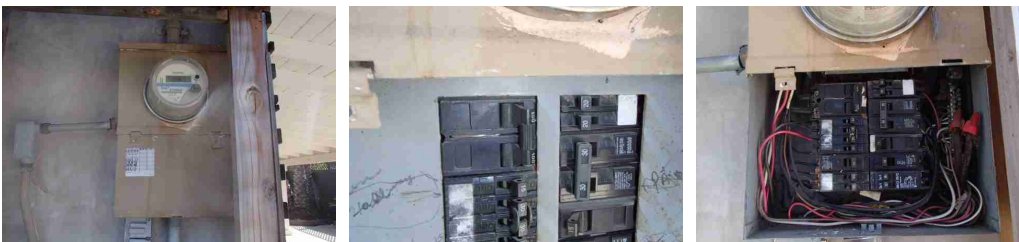
The residence is served by a 100 amp, 110-220 volt panel, located on the side of the residence.

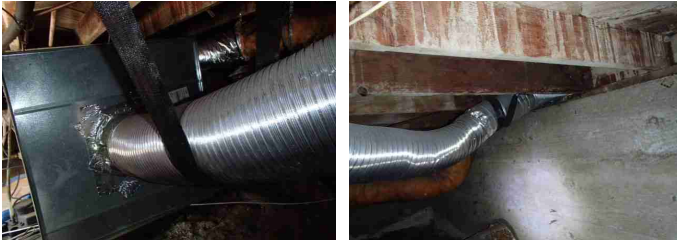
The return air compartment draws outside air, which is not as efficient as one that recirculates interior air and this should be evaluated by a licensed specialist before close of escrow.

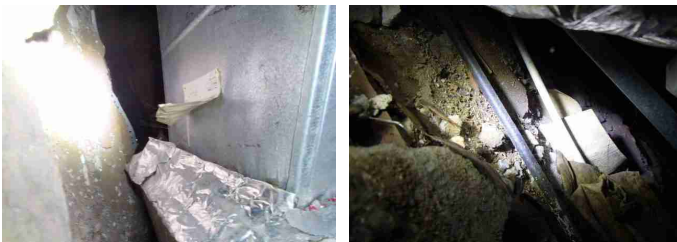
Energy is being lost at the seams of the evaporator coil and furnace in the crawlspace which should be sealed.

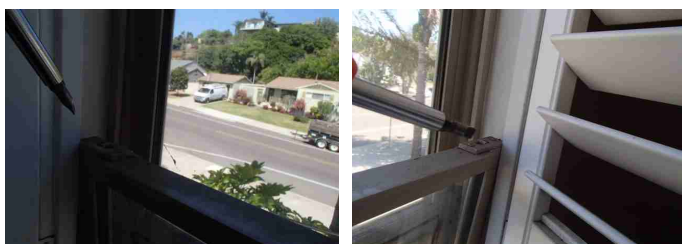
The window clips are broken on one of the windows and the window will not stay in the tracks properly and needs serviced.

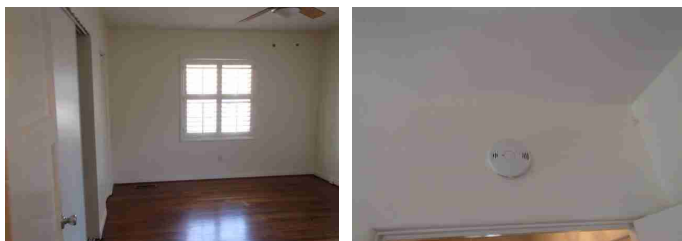
Smoke & Carbon Monoxide Detector

The smoke and carbon monoxide detector was functional and should be checked periodically.

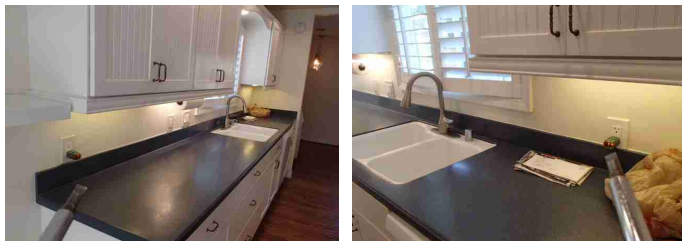
The outlets within 6 feet of water should have ground-fault protection, especially with six feet of a water source, which is mandated by current standards and is an important safety feature.

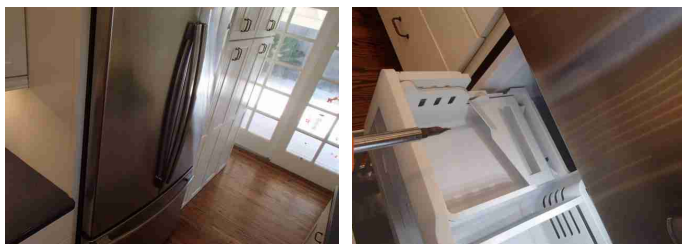
The ice maker was off at the time of the inspection and you may wish to ask the sellers if the unit is functional.

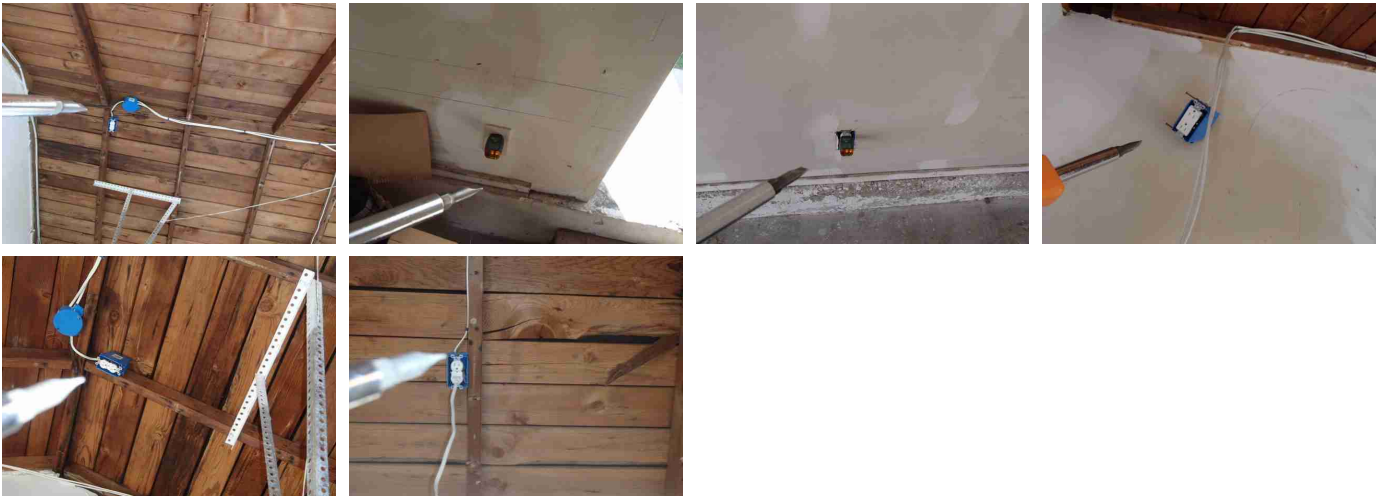
All the outlets should have ground fault protection, which is mandated by current standards and is an important safety feature.
