# Inspection Report

**Property Address:**  
4749 Constance Dr  
San Diego CA 92115

**Foresight Building Inspection**

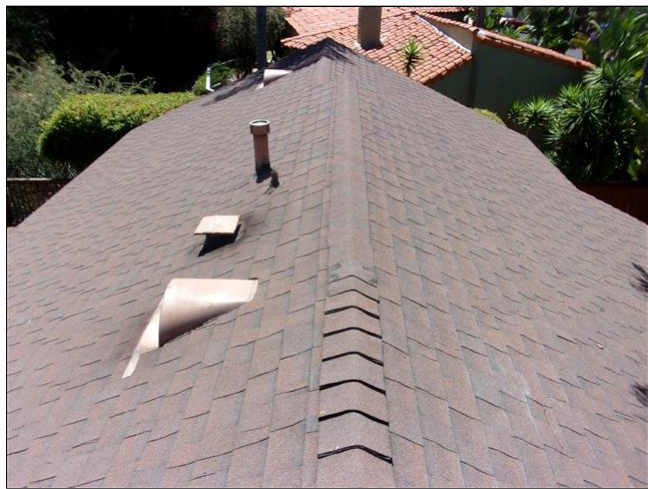
The asphalt composition shingles have been installed over wood shake/shingles, which is not an approved method of installation. Proper installation of new shingles will require some upgrades to the roof sheathing system. It is recommended to contact a licensed roofing company for evaluation and cost estimates for any eventual roof-covering replacement.

1.0 Item 1(Picture) recommend further evaluation of asphalt shingles over wood shake

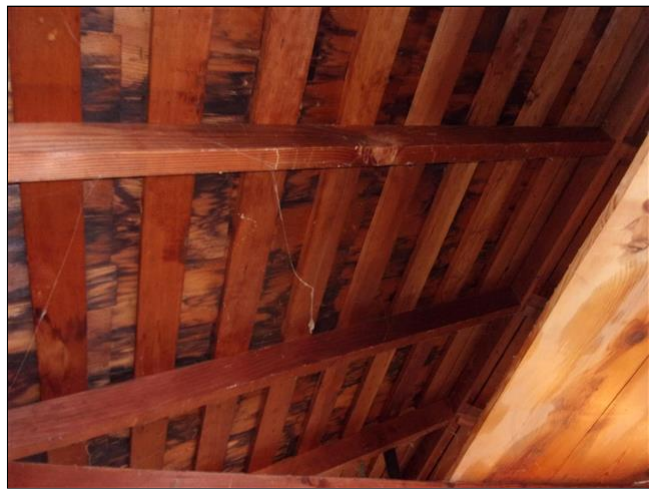
1.0 Item 2(Picture) asphalt shingles were installed over wood shake

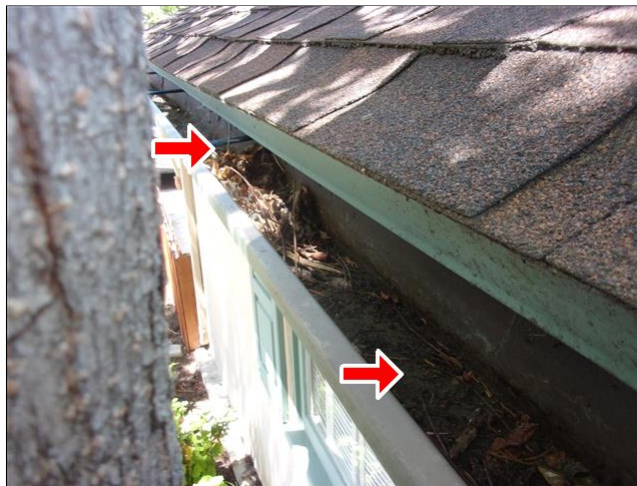
Defects or deficiencies were observed at one or more areas of the downspout components. It is recommended to have the system evaluated by a rain gutter specialist and repaired/replace as needed.

1.1 Item 2(Picture) rain gutter cleaning needed

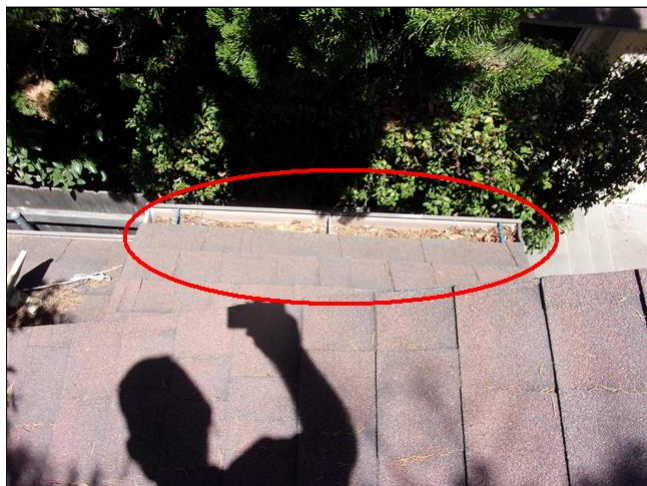
1.1 Item 3(Picture) rain gutter cleaning needed

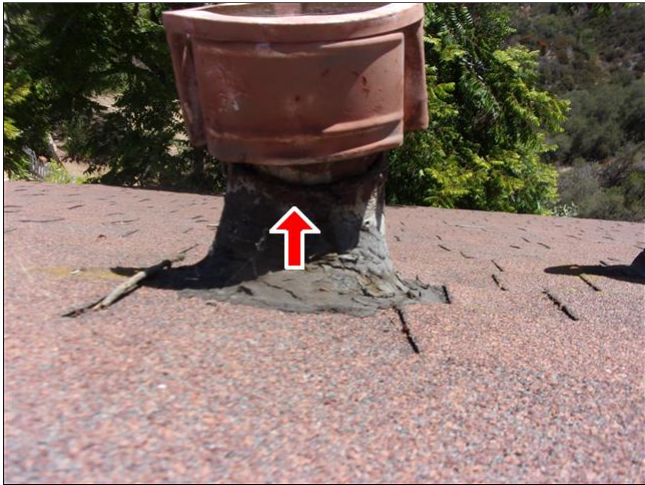
Repairs are needed at areas of the vent boot flashings where sealant was missing, deteriorated, or separated. It is recommended to have a licensed roofer evaluate and correct as needed.

1.2 Item 1(Picture) boot flashing sealant separation visible

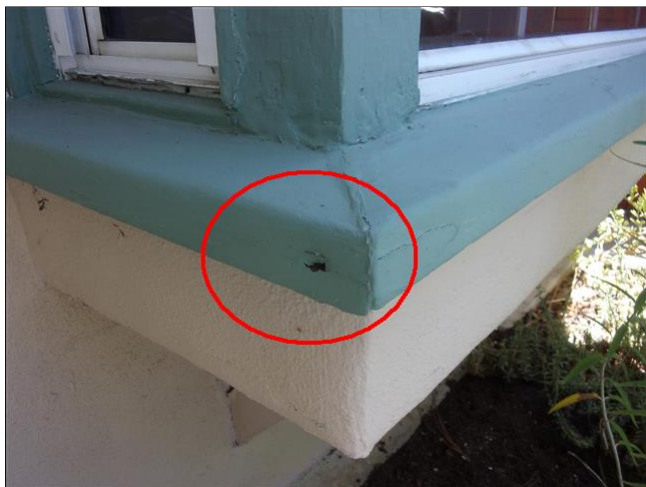
(1) Possible WDO (wood destroying organisms) evidence or damage was observed at areas of the exterior window systems. It is recommended to have a licensed pest control company evaluate all WDO related defects and remediate as needed.

2.2 Item 1(Picture) near entry: possible WDO evidence or damage observed

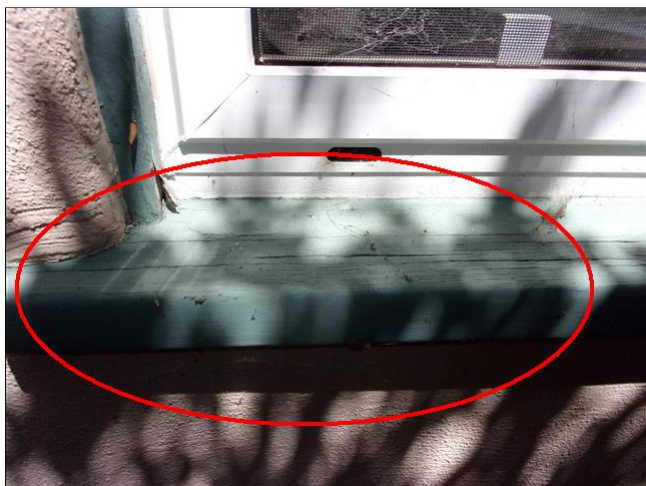
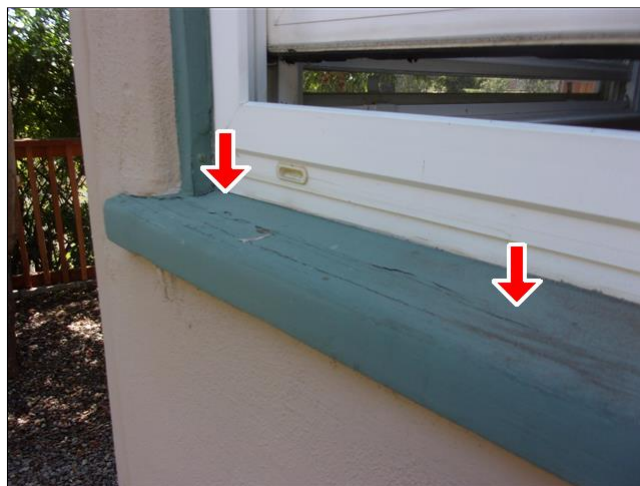
(2) The paint, caulking, or sealant at the exterior windows was damaged, deteriorated, or had other observable defect. It is recommended to have the paint evaluated by a qualified painter and repaired/replaced as needed.

2.2 Item 2(Picture) window sill/trim: paint maintenance/repairs needed

2.2 Item 3(Picture) window sill/trim: paint maintenance/repairs needed

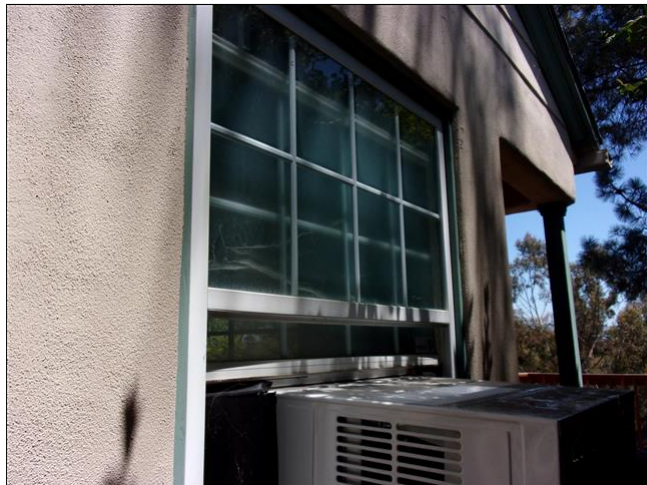
(3) There was possible condensation, cracking in the seal, or other visible defect observed at one or more of the dual-paned windows indicating the glazing assembly may need to be repaired or replaced. This is often difficult to detect if windows are dirty or at the second story. A further inspection to determine dual pane seal performance by a window glazing specialist is recommended.

2.2 Item 4(Picture) possible evidence of dual pane seal defect observed

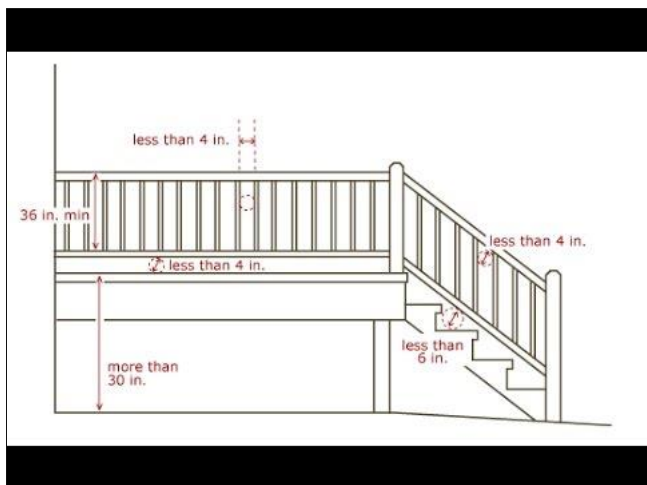
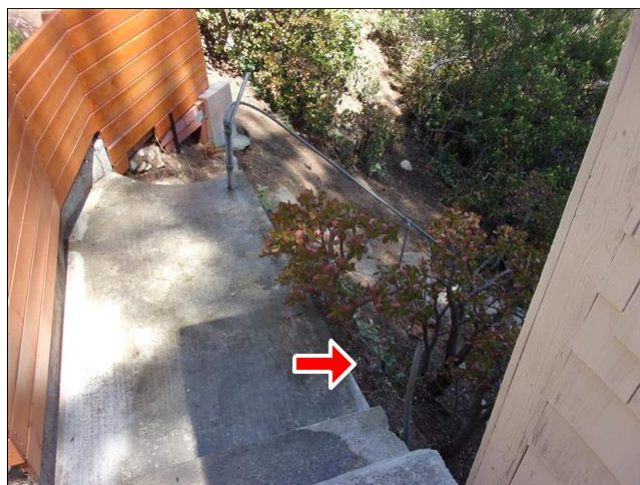
2.3 Item 2(Picture) fall hazard / railing safety upgrades recommended

Stair and guard railing heights and spacing requirements have improved over the years to increase safety and decrease potential fall hazards. While the current systems present may have been acceptable at the time of construction, it is recommended to have stair and guard railing systems evaluated and upgraded as needed to modern safety standards.

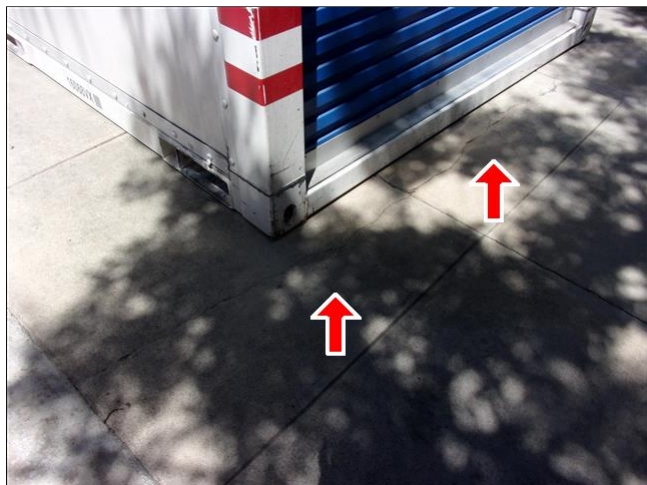
(1) Cracking, damage, or other visible defect was observed at areas of the exterior hardscape (driveway, walkway, stairs, patio, etc.). It is recommended to have these evaluated by a licensed contractor and repaired/replaced as needed.

2.4 Item 1(Picture) cracks visible at concrete driveway

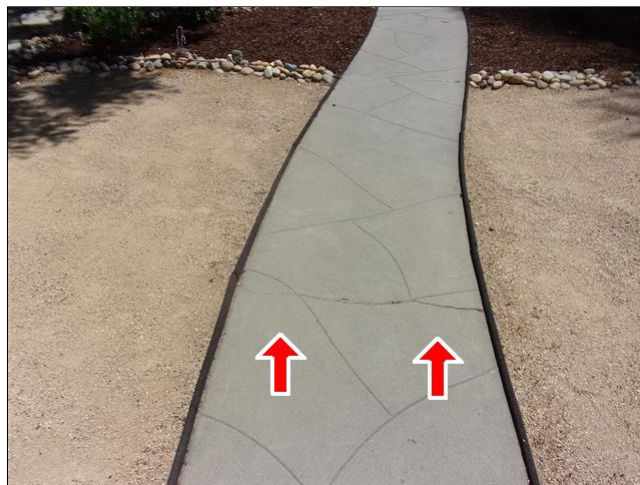
2.4 Item 2(Picture) crack in walkway

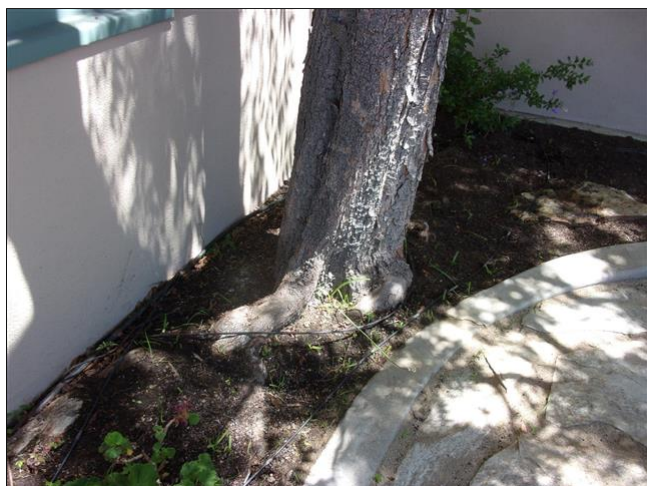
(2) Trees, shrubs, or other vegetation near the property can cause damage as root systems and branches grow. It is recommended to contact a licensed arborist or landscaping contractor for further evaluation and correction or removal as needed.

2.4 Item 3(Picture) trees/large shrubs next to the building exterior are not recommended

Overgrown vegetation, excessive irrigating, or other landscaping corrections and improvements are recommended. Consult with a qualified landscaping company for recommendations and corrections as needed.

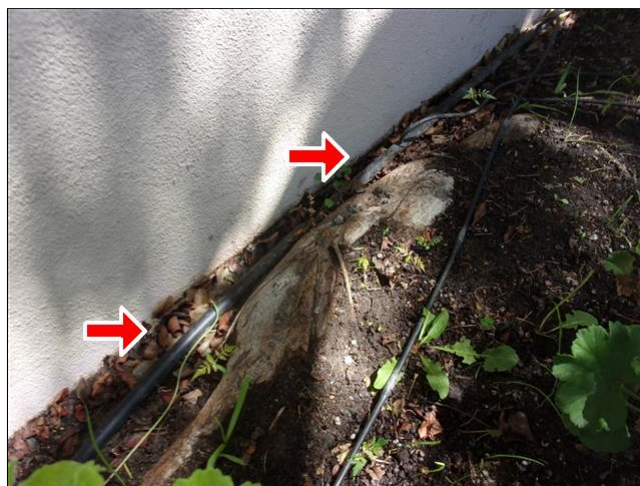
2.4 Item 4(Picture) irrigation systems next to build foundation are not recommended

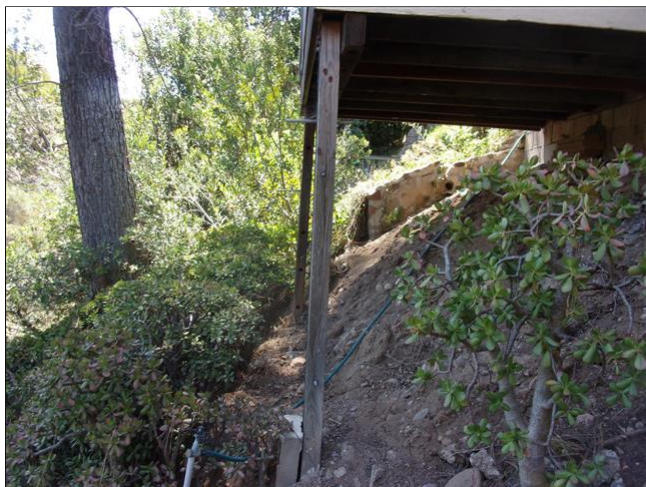
(3) Disclaimer: This inspection does not evaluate soil stability. Because the location of the house was on or near a hillside and evaluating ground soil stability is outside the scope of this inspection, it is recommended to contact an appropriate soil engineer for further evaluation.

2.4 Item 5(Picture) hillside stability was not inspected or tested as part of the scope of this inspection

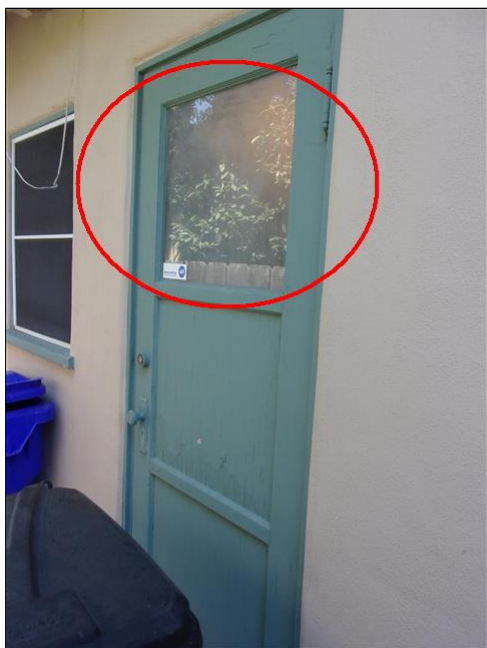
2.8 Item 1(Picture) recommend evaluation and upgrade of any non-safety glass windows at appropriate locations

Because identification of safety glass is not always possible at the time of the inspection, due to the age of the window or glass door panes, safety glass may not be present. While safety glass may not have been required at the time of construction, as a safety upgrade, it is recommended to contact a glazing specialist for evaluation of any window or door panes that would now require safety glass and upgrade as needed.

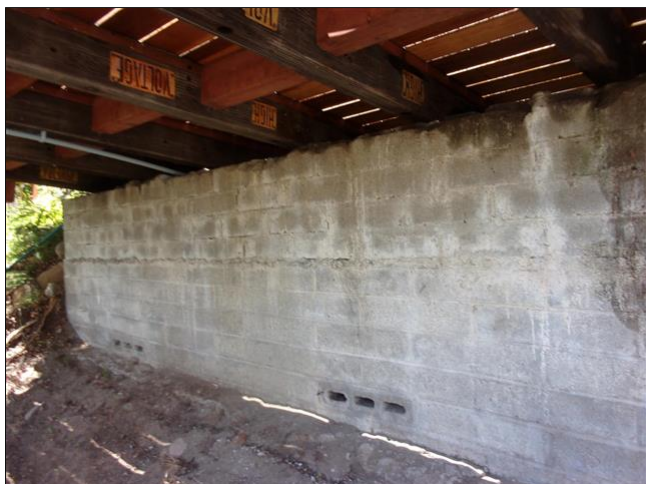
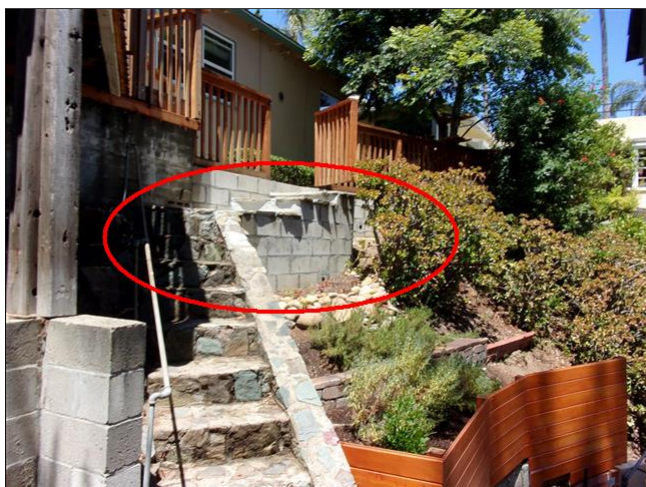
2.8 Item 2(Picture) retaining walls were not inspected or tested as part of the scope of this inspection / recommend further evaluation

2.8 Item 4(Picture) retaining walls were not inspected or tested as part of the scope of this inspection / recommend further evaluation

(2) Note: Retaining walls are not inspected as part of the scope of this inspection. Further evaluation from a qualified person (contractor, engineer, etc.) is recommended to determine serviceability.

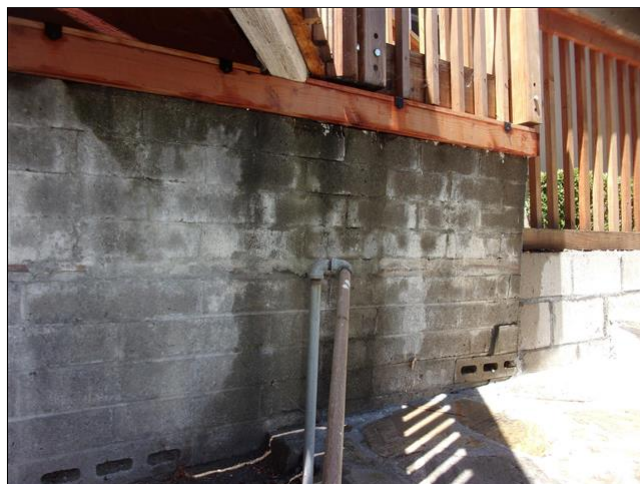
2.8 Item 3(Picture) retaining walls were not inspected or tested as part of the scope of this inspection / recommend further evaluation

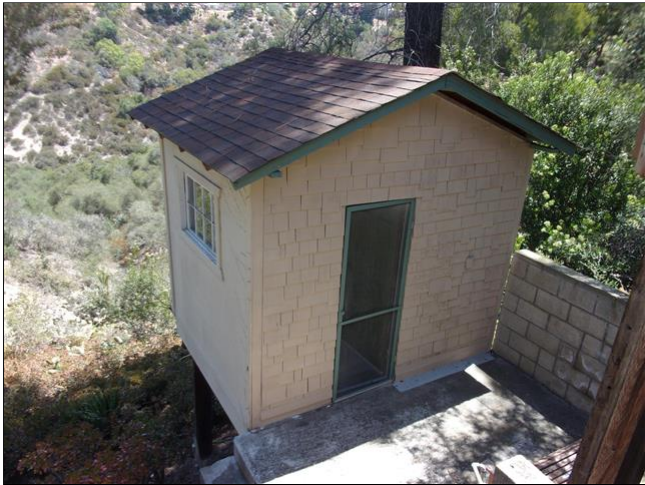
(3) Note: While storage or utility sheds are not inspected as part of the scope of this inspection, some defects were observed. Because these additions are commonly under-constructed or may not have been built according to construction industry standards, further evaluation is recommended from a qualified contractor.

2.8 Item 5(Picture) shed was not inspected or tested as part of the scope of this inspection

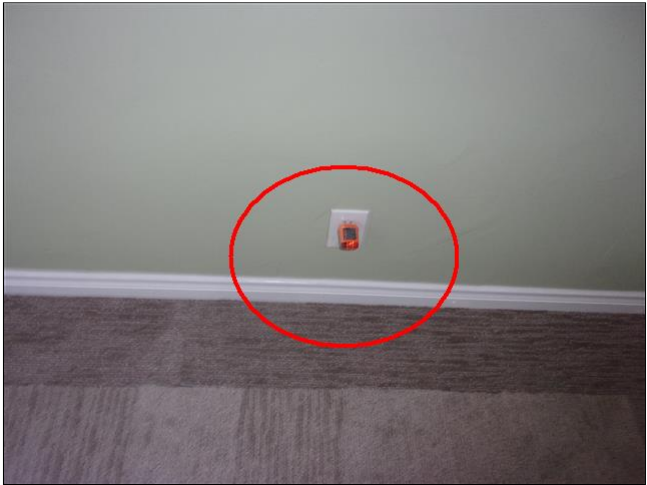
2.8 Item 6(Picture) non-grounded three-pronged outlets observed

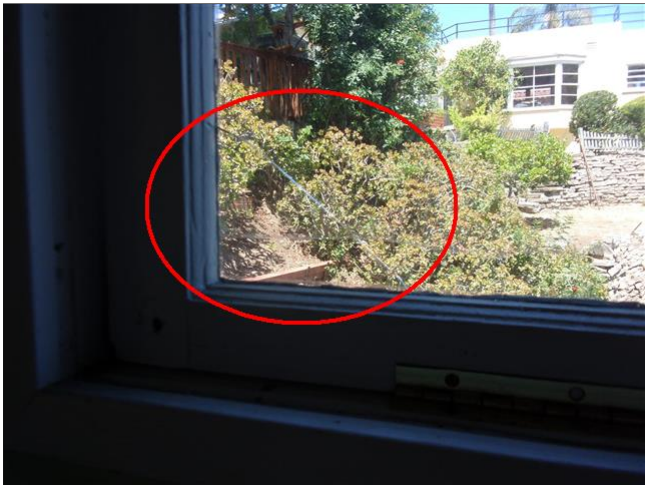
2.8 Item 7(Picture) broken window pane

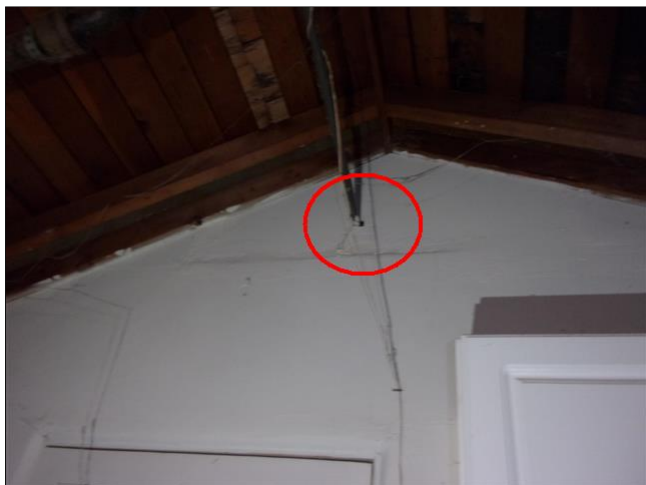
There were holes, damages, or other breaches observed in the garage firewall separation (the wall and/or ceiling that separates the garage from the living areas). All penetrations (damages, holes, attic access, etc.) in the garage firewall should be evaluated and corrected as needed.

3.1 Item 1(Picture) penetrations observed in garage firewalls

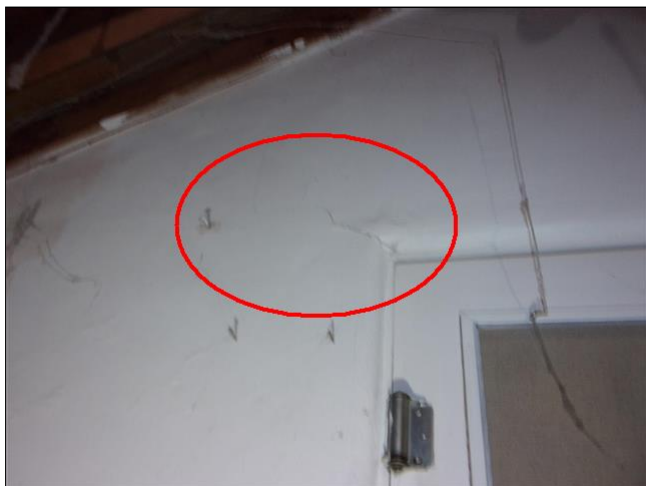
Disclaimer: Cracks in the ceiling and/or walls may be a result from possible settling, movement, or other structural defect. This inspection is not meant to be a structural evaluation but an observation of visible physical defects. Only further evaluation and investigation from a qualified person can determine if non-visible defects are present.

3.2 Item 1(Picture) cracks in garage wall observed

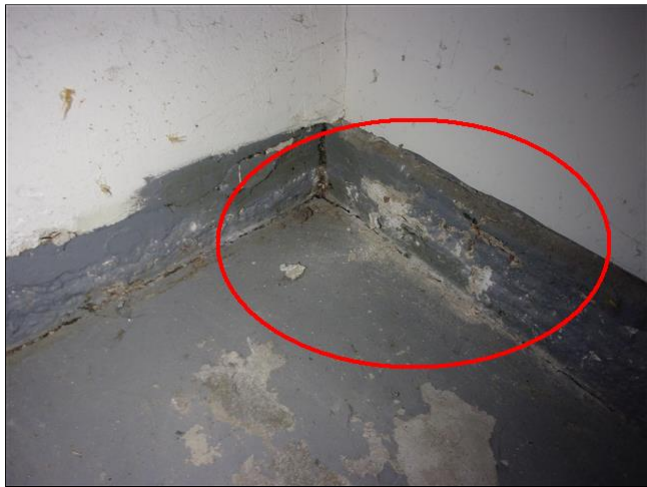
(1) Moisture stains or other possible evidence of moisture intrusion was observed at the garage floors. Further evaluation is recommended to determine cause of moisture intrusion and correction as needed.

3.3 Item 1(Picture) efflorescence observed (drip irrigation observed at adjacent side of garage wall)

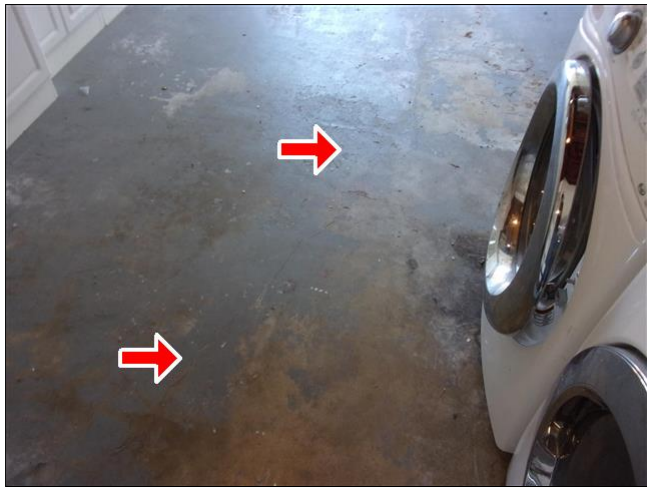
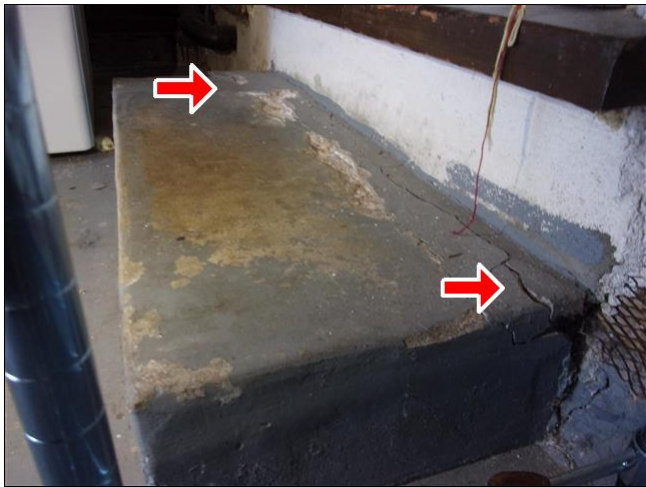
(2) Cracks were observed at the garage concrete slab. Concrete cracks may occur during the curing process as concrete dries and shrinks or may be the result settling, movement, or structural defect that has occurred. Because the scope of this inspection is only to observe and document, further evaluation is required to determine the cause of cracks and correction as needed.

3.3 Item 2(Picture) cracks visible at garage floor

3.3 Item 3(Picture) cracks visible at garage step

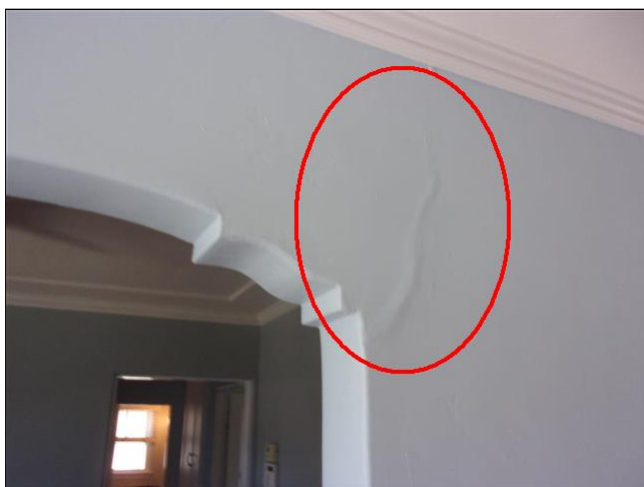
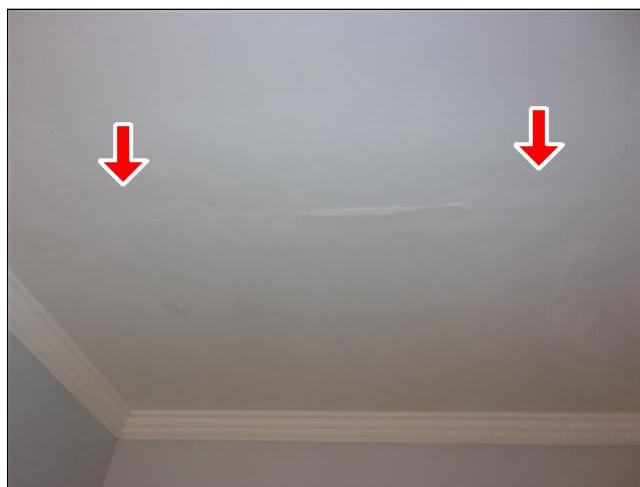
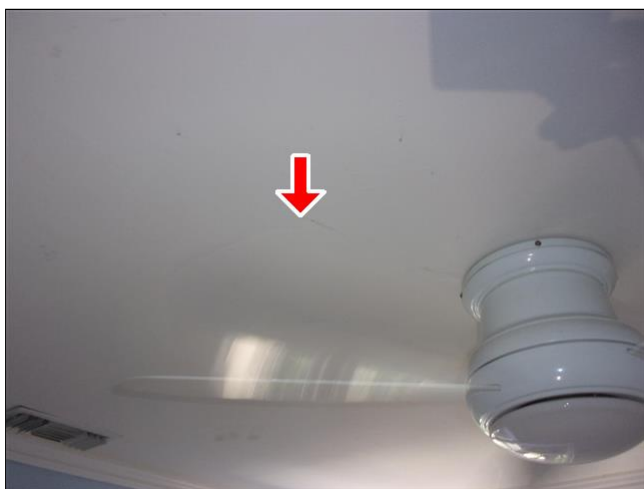
(1) Disclaimer: Cracks in the ceiling and/or walls may be a result from possible settling, movement, or defect that has occurred. This inspection is not meant to be a structural evaluation but an observation of visible physical defects. Only further evaluation and investigation from a qualified person can determine if non-visible defects are present and corrections as needed.

4.0 Item 1(Picture) cracks visible at interior wall

4.0 Item 2(Picture) cracks visible at bathroom ceiling

4.0 Item 3(Picture) cracks visible at bedroom ceiling

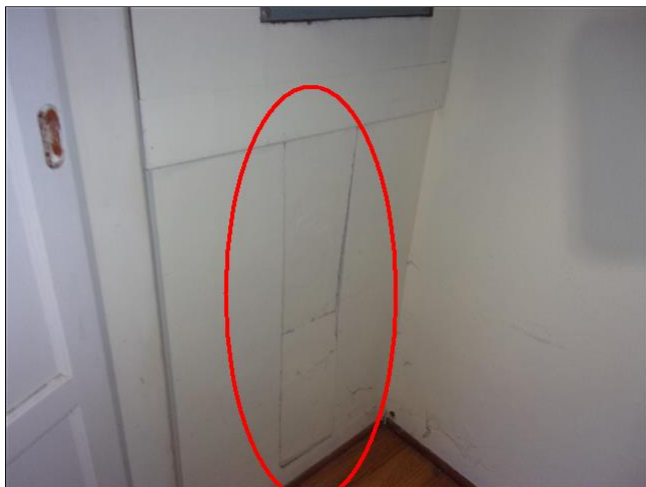
(2) Damages, missing drywall, or other defects to the walls or ceilings were observed. It is recommended to have these walls and ceilings evaluated by a qualified tradesman and repaired/replaced as needed.

4.0 Item 4(Picture) bedroom closet: wall maintenance/repairs needed

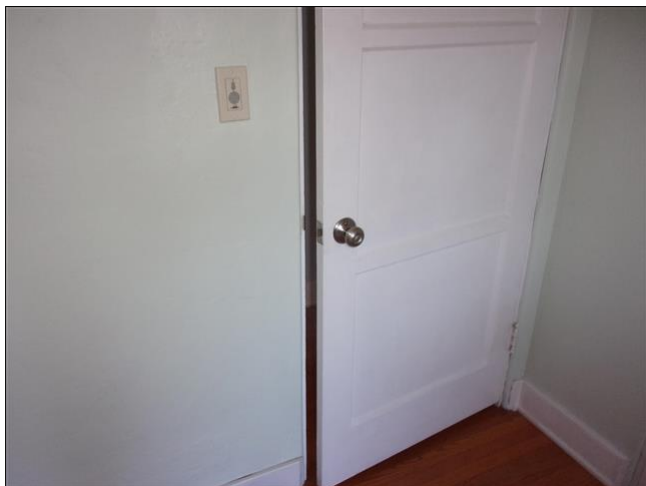
A representative number of doors was tested. One or more of the tested doors or hardware had signs of damage, defect, or did not operate properly when tested. It is recommended to have all doors and hardware defects evaluated and repaired/replaced as needed.

4.3 Item 1(Picture) door did not latch properly when tested

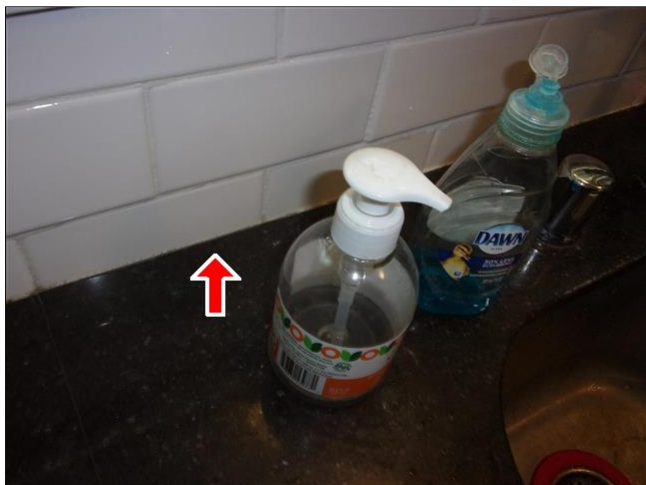
Caulking or grout defects were observed at areas of the countertops, backsplash, or sink fixtures where caulking or grout was missing, deteriorated, or had other observable defect.

4.4 Item 1(Picture) kitchen: caulking or appropriate sealant maintenance/repairs needed

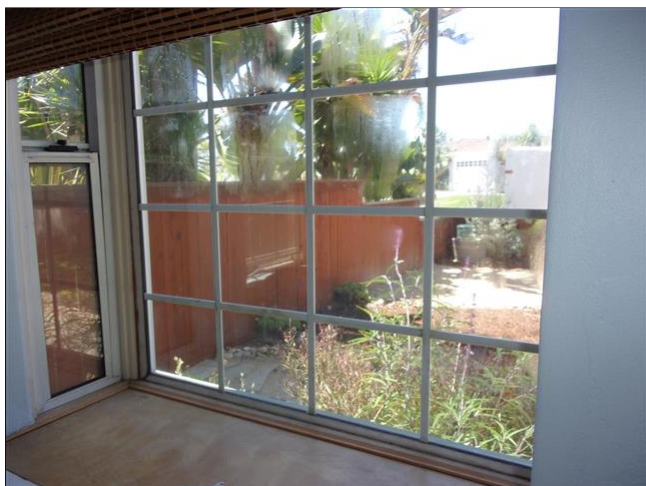
There was possible condensation, cracking in the seal, or other visible defect observed at one or more of the double-paned windows indicating the glazing assembly may need to be repaired/replaced. Consult with a licensed window glazer for evaluation and correction as needed.

4.5 Item 1(Picture) possible evidence of dual pane seal defect observed

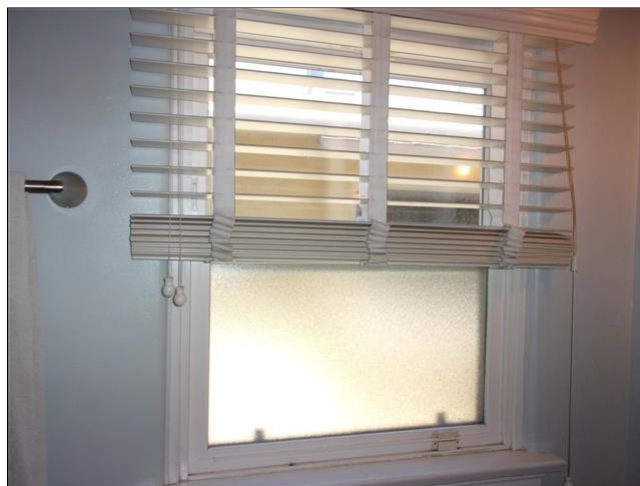
4.5 Item 2(Picture) bathroom window did not operate properly when tested

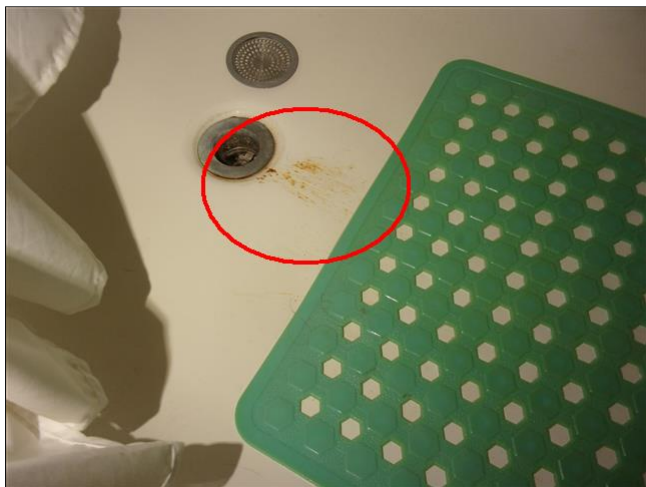
There was visible damage, deterioration, or other observable defect at the tub or shower pan/surround that should be evaluated and repaired as needed.

4.6 Item 1(Picture) oxidation visible at tub surface

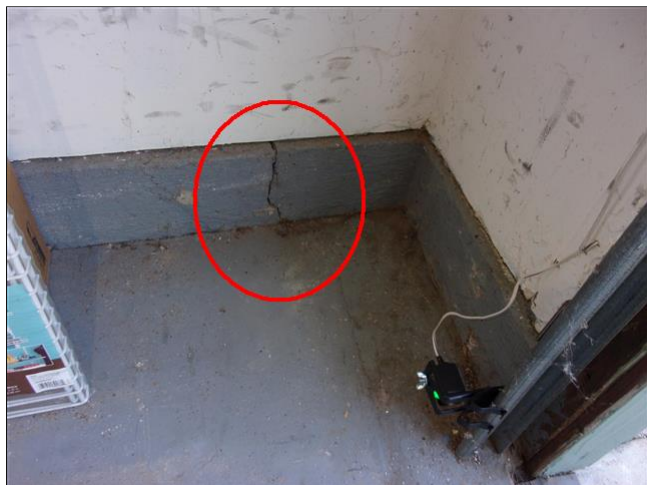
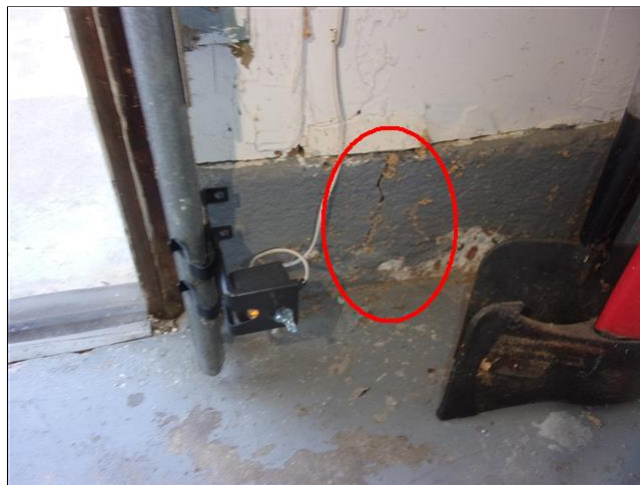
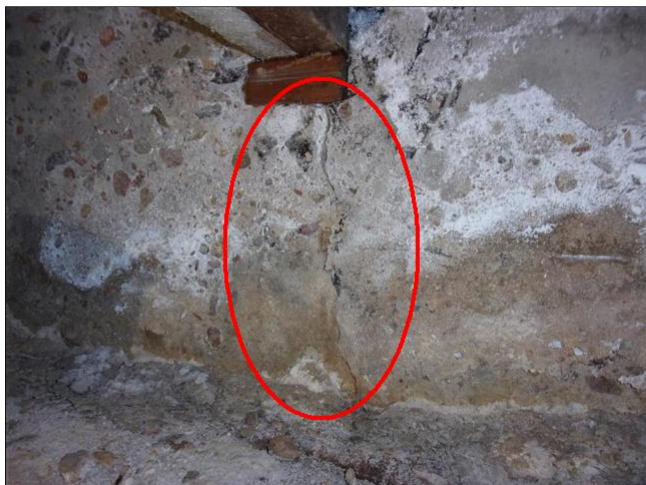
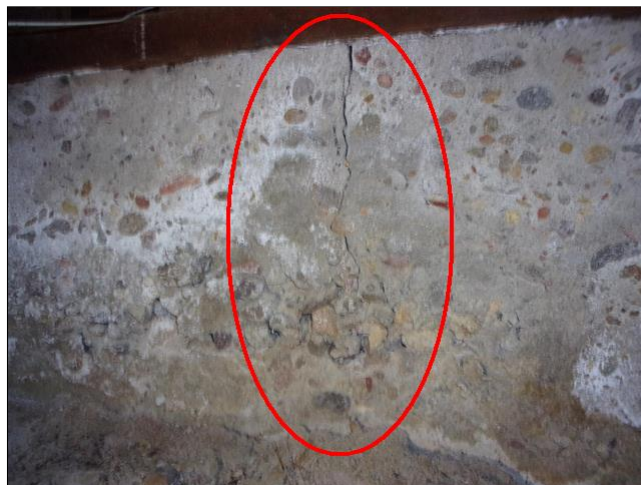
There were cracks, deterioration, or other observable defects visible at areas of the foundation wall system or components. It is recommended to have a qualified licensed contractor or engineer evaluate to determine if repairs or replacement are needed.

5.0 Item 1(Picture) cracks observed at garage foundation stem wall

5.0 Item 2(Picture) cracks observed at garage foundation stem wall

5.0 Item 5(Picture) cracks visible at the foundation stem wall

5.0 Item 6(Picture) cracks visible at the foundation stem wall

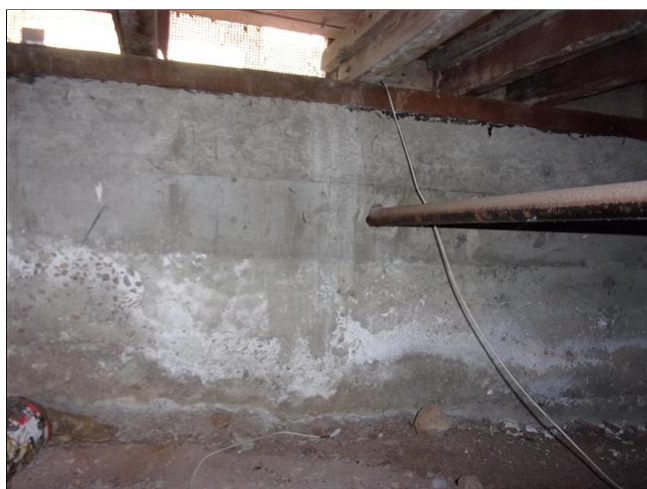
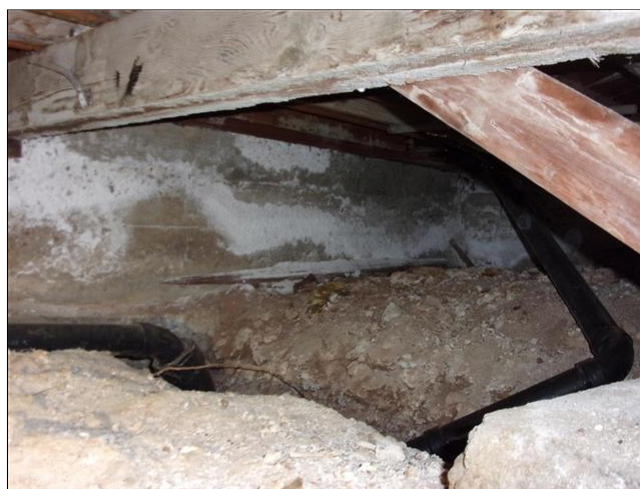
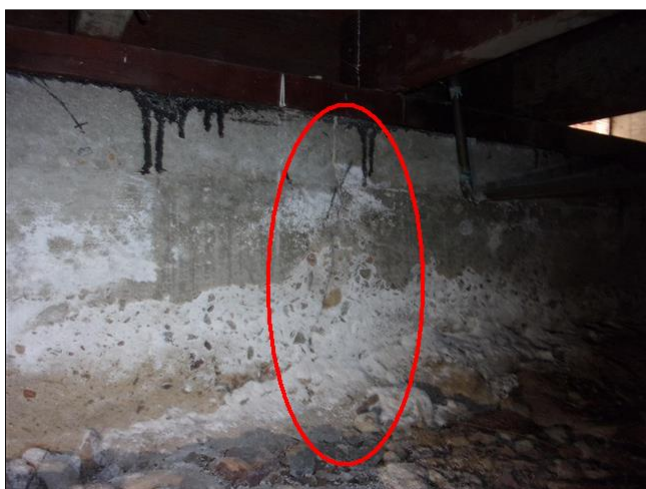
Possible efflorescence was visible on or around areas of the foundation wall systems indicating possible moisture contact or intrusion by the foundation. Because moisture by the foundation walls can increase rate of deterioration, further evaluation from a qualified specialist is recommended determine the cause of moisture and corrections/ improvements as needed.

5.0 Item 3(Picture) efflorescence observed at the foundation stem wall

5.0 Item 4(Picture) efflorescence observed at the foundation stem wall

5.0 Item 7(Picture) cracks visible at the foundation stem wall / efflorescence observed

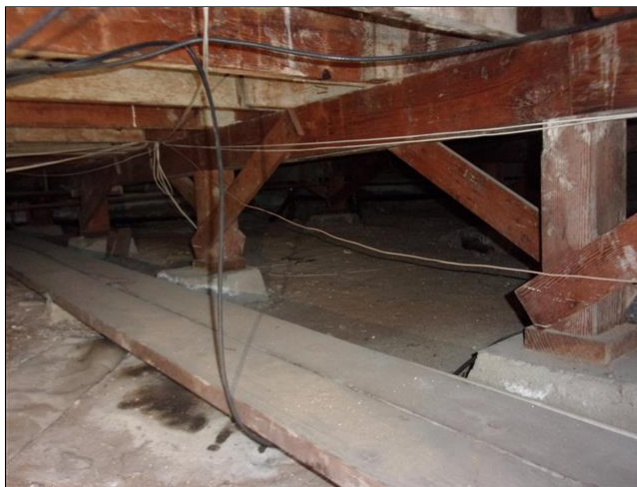
The foundation post and pier system appeared constructed conforming to the standards of the era it was built. However, these standards would not meet modern building standards, which have improved over the years to protect homes against natural and unnatural occurring stresses on the foundation such as settling, deterioration, or seismic activity. Metal strap connectors and shorter distances between posts are examples of these upgrades. It is recommended to contact and licensed contractor regarding upgrades to the foundation post and pier system.

5.1 Item 2(Picture) post and pier seismic strapping/  
anchoring upgrades recommended

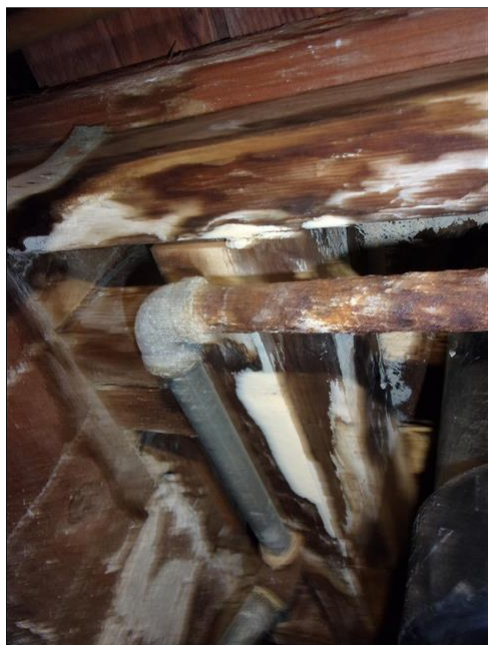
Moisture stains or other evidence of past moisture intrusion were observed at areas of the flooring system. No moisture was observed at the time of the inspection. Only further evaluation and investigation can determine the cause and identify presence of hidden damages.

5.2 Item 1(Picture) below bathroom:  
moisture stains or damage visible

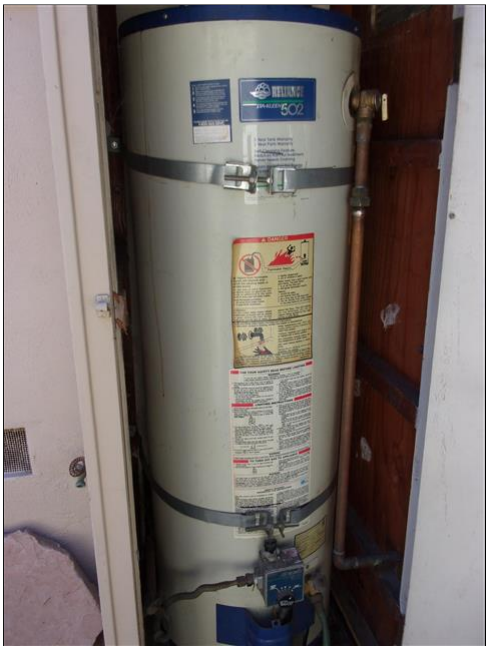
The water heater was operational at the time of the inspection but may have exceeded or is near to exceeding its expected serviceable life. Further evaluation from a qualified plumber is recommended to determine current servicing/ maintenance needs and the remaining life expectancy.

6.0 Item 1(Picture) aged water heater

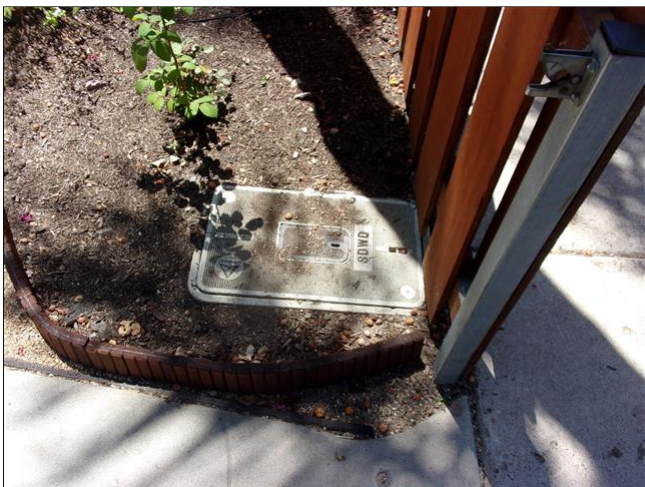
6.1 Item 1(Picture) water meter and main shut-off

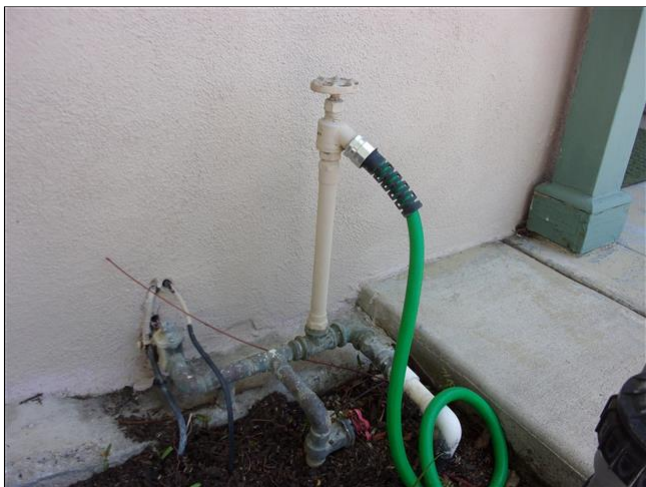
6.1 Item 2(Picture) house water shut off valve

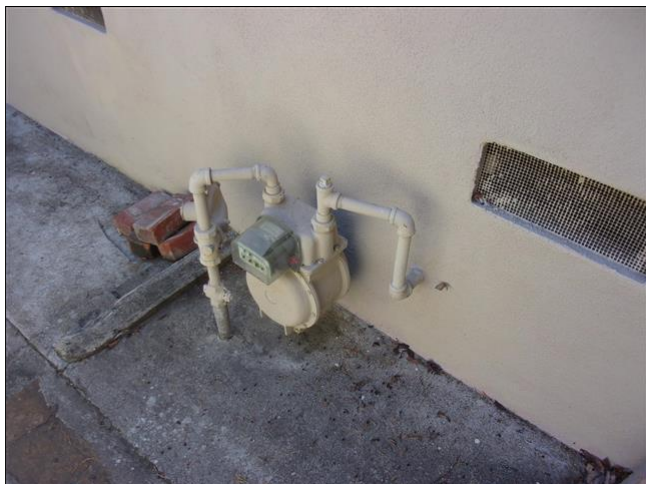
6.2 Item 1(Picture) gas meter and shut-off valve

Because determining if the fuel system is free of leaks, it is recommended to have SDG&E (San Diego Gas and Electric) perform a routine service check up. Please contact SDG&E for more information:

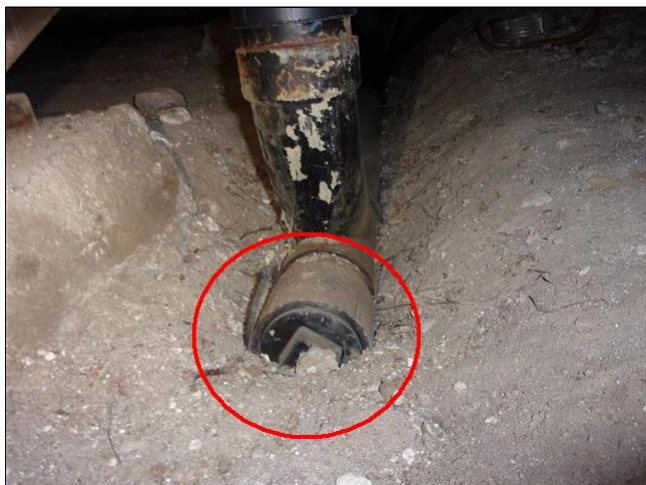
Plumbing DWV (drain, waste, vent) systems may have hidden defects that can only be detected with further inspection from a qualified plumber who provides drain video/camera inspections. Because the scope of this inspection is limited to only visible and accessible systems and components, it is recommended to contact a licensed plumber for further inspection and evaluation.

6.3 Item 1(Picture) sewer camera inspection

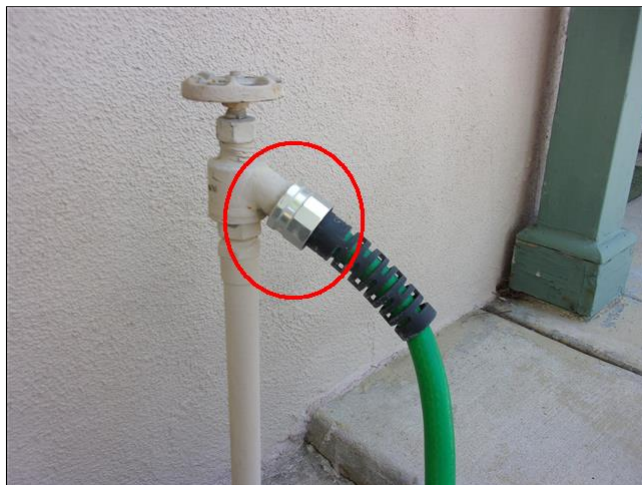
6.4 Item 2(Picture) aged water supply valves/hoses observed

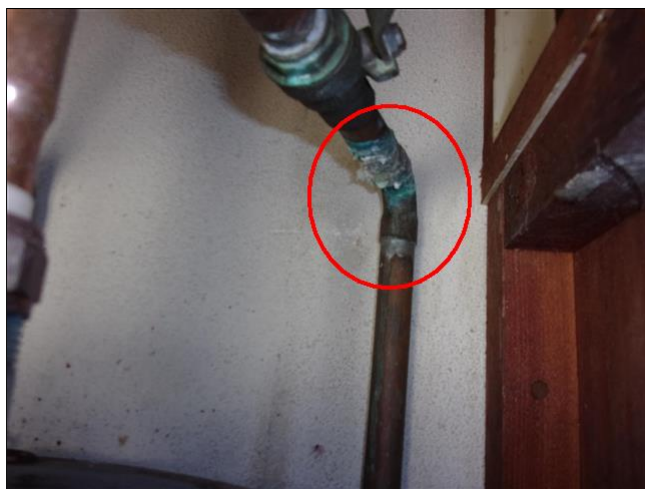
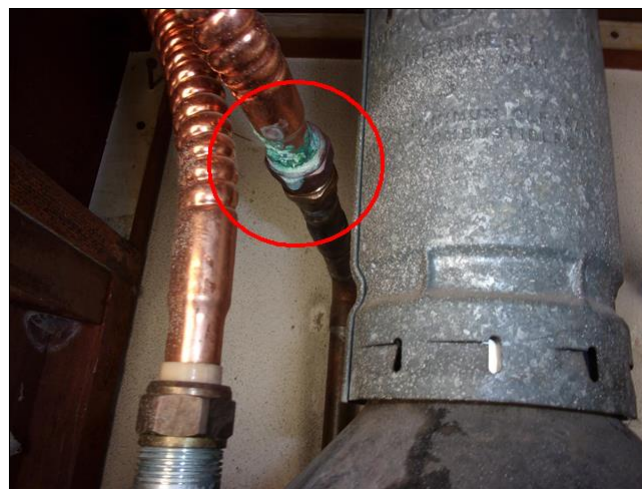
(2) There was damage, deterioration, or other observable defect in the plumbing water supply. It is recommended to have the water distribution system and components evaluated by a licensed plumber and repaired/replaced as needed.

6.4 Item 3(Picture) near water heater: leaking observed at water supply

6.4 Item 4(Picture) near water heater: leaking observed at water supply

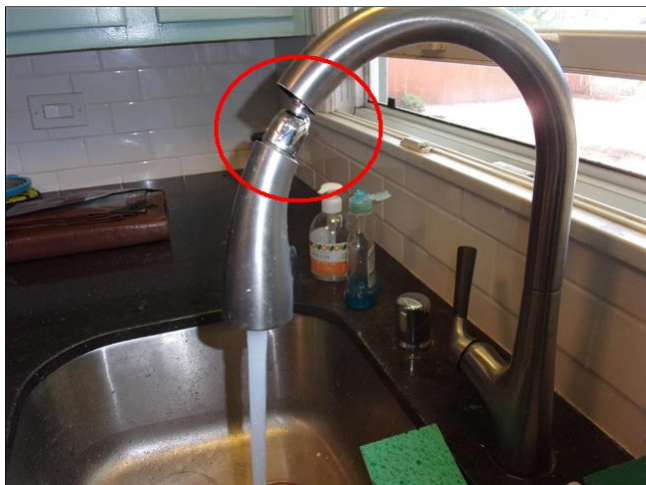
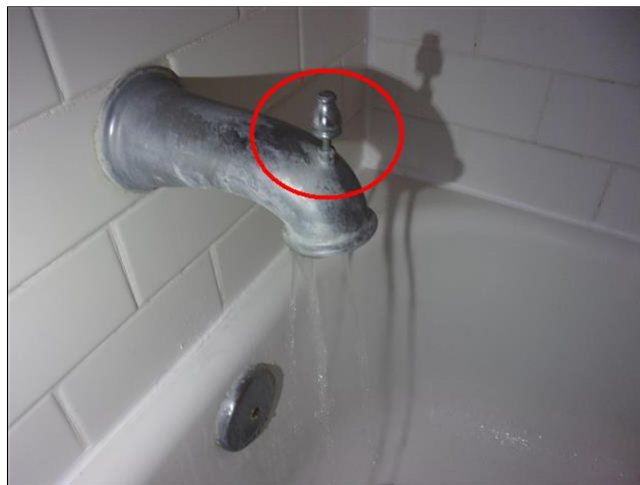
One or more of the plumbing fixtures (toilets, sinks, faucets, tub/shower valves, etc.) were loose, leaked during operation, or had other observable defect. It is recommended to have the fixtures evaluated by a licensed plumber and repaired/replaced as needed.

6.5 Item 1(Picture) kitchen: faucet leaked during testing

6.5 Item 2(Picture) tub spout diverter did not operate properly when tested

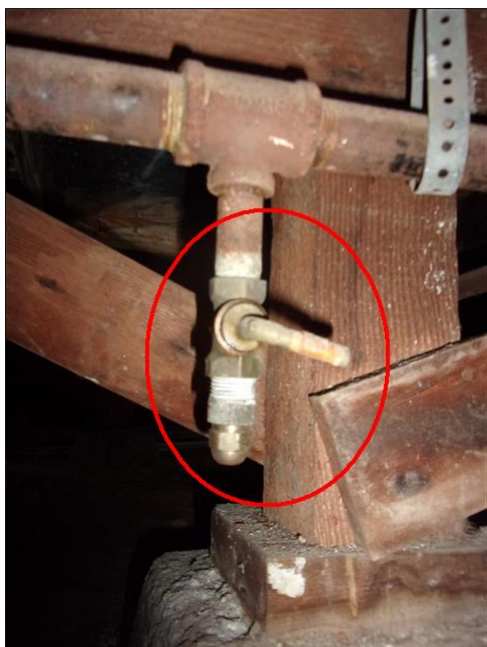
A possible gas odor was observed in the fuel supply line. Contact a licensed plumber immediately for evaluation and inspection of the fuel supply system and components.

6.6 Item 1(Picture) subfloor area below bathroom: gas odor observed / recommend further evaluation

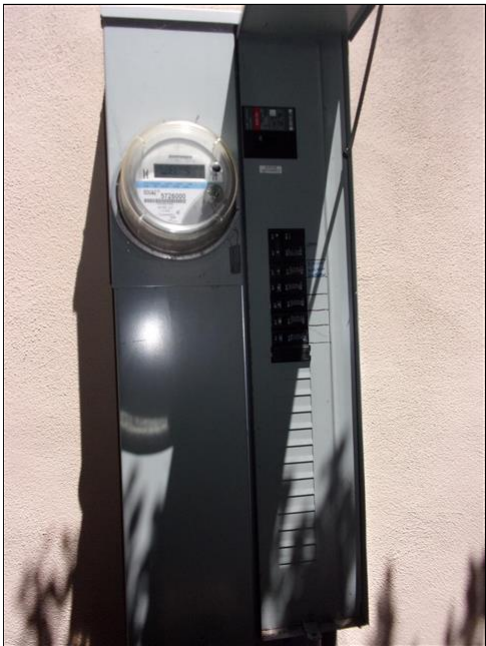
7.2 Item 1(Picture) electric meter and main panel

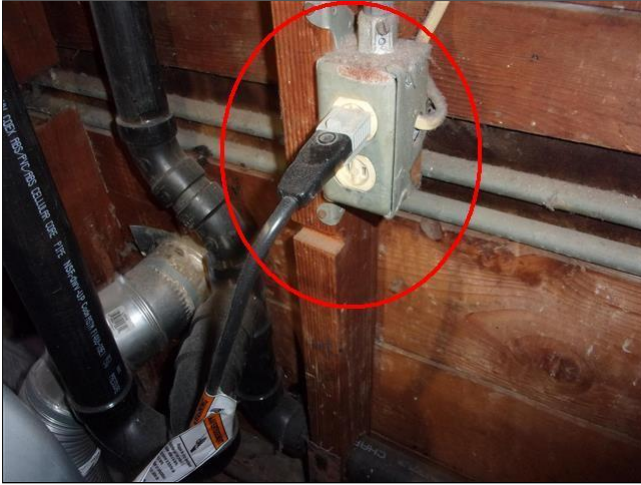
Improper wiring method, damages, or other defects were observed at areas of the branch circuit wiring or breaker system. All electrical system and component defects should be considered safety hazards. It is recommended to have the systems evaluated by a licensed electrician and repaired/replaced as needed.

7.4 Item 1(Picture) laundry washing machine needs a three pronged grounded outlet
