# Inspection Report

**Property Address:**  
4749 Constance Dr  
San Diego CA 92115

**Foresight Building Inspection**

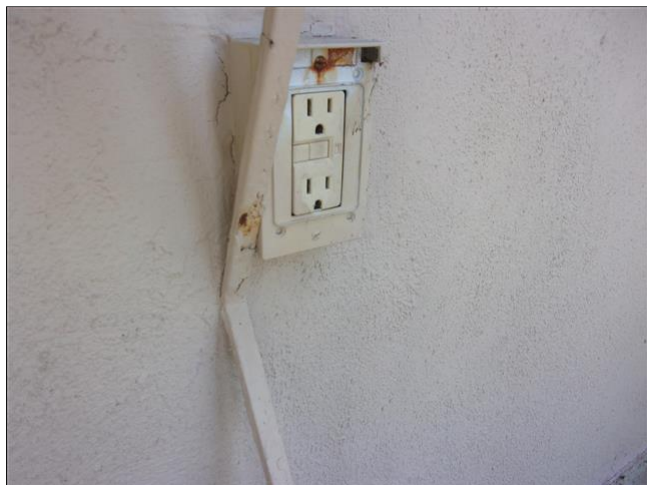
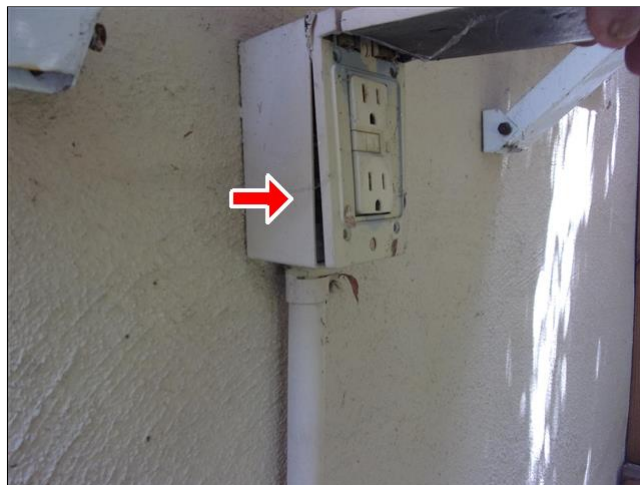
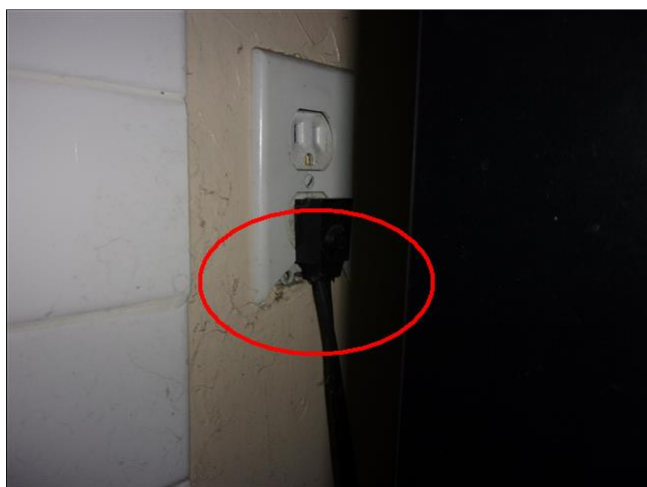
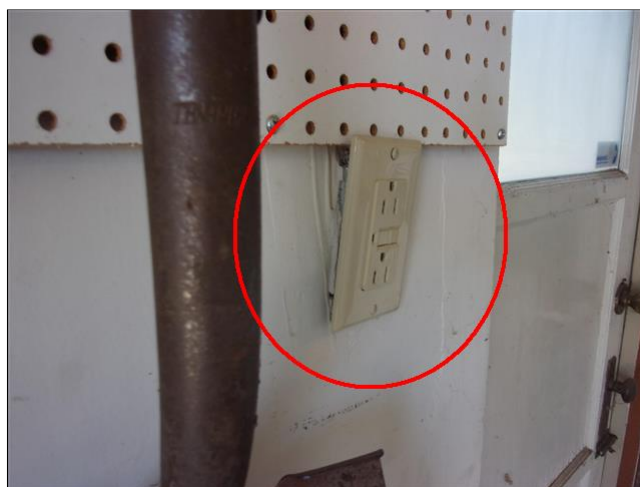
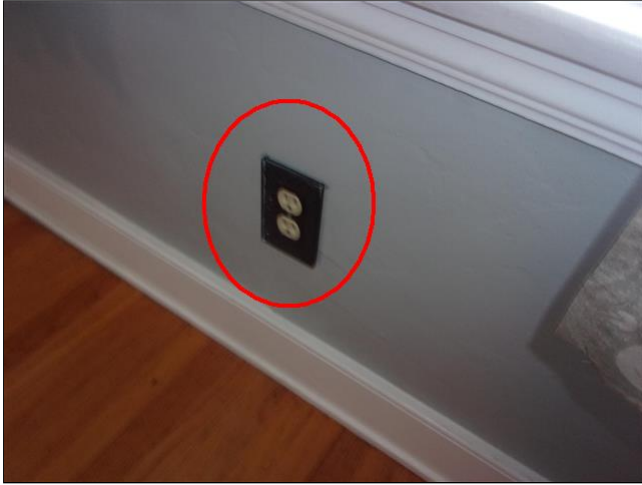
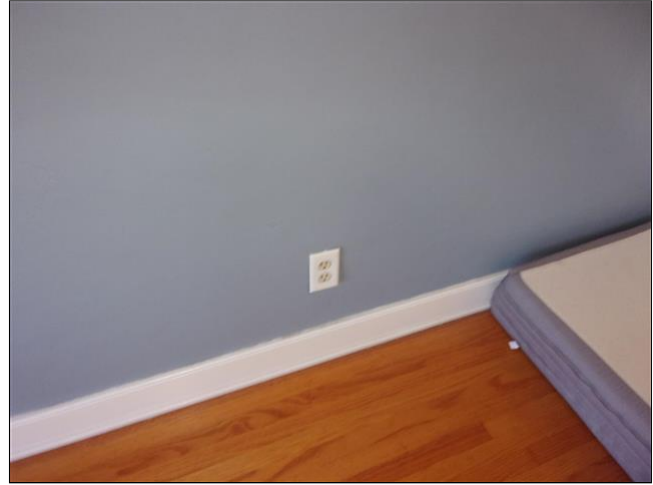
Defects were observed at one or more of the outlets, switches, or fixtures. All electrical system and component defects should be considered safety hazards. It is recommended to have a licensed electrician evaluate all outlets, switches, and fixtures and repair/replace as needed.

7.5 Item 1(Picture) missing exterior outlet cover

7.5 Item 2(Picture) exterior: loose outlet

7.5 Item 3(Picture) kitchen: outlet cover maintenance/ repairs needed

7.5 Item 4(Picture) garage: loose outlet

7.5 Item 5(Picture) loose outlet

7.5 Item 6(Picture) loose outlet

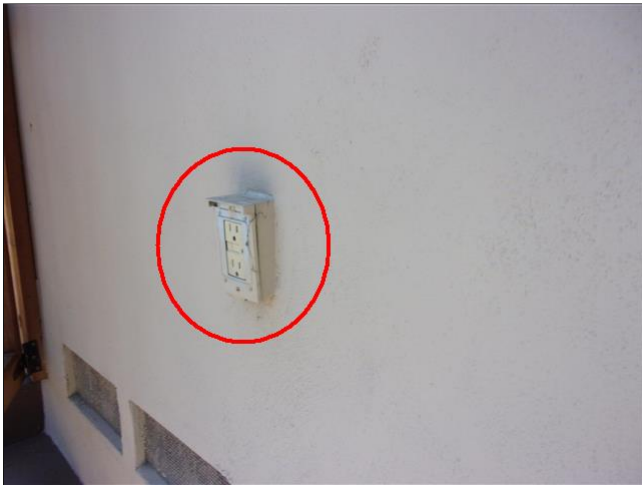
7.5 Item 7(Picture) missing outlet cover

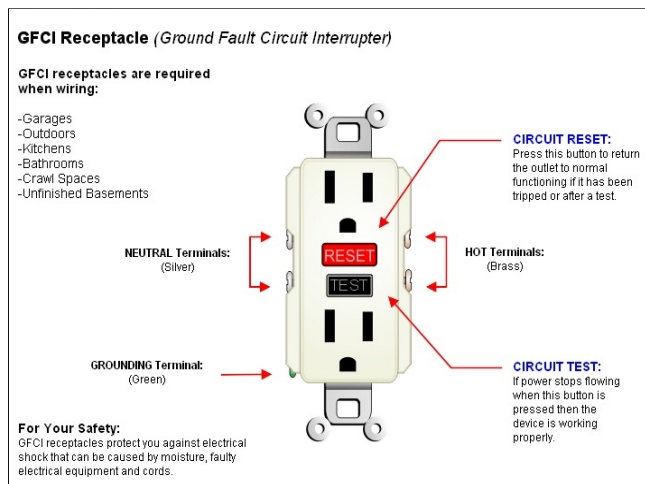
### 7.6 Item 1(Picture)

One or more outlets observed in the kitchen, bathroom, exterior, or garage did not appear to be GFCI protected. While this may have been acceptable at the time of construction, current standards require that all kitchen countertop outlets, bathroom outlets, exterior outlets, and garage outlets must be GFCI. Other auxiliary systems may also require GFCI outlets such as pool pumps, sumps, and jacuzzi jet motors. It is recommended to have a licensed electrician evaluate the appropriate GFCI locations and upgrade as needed.

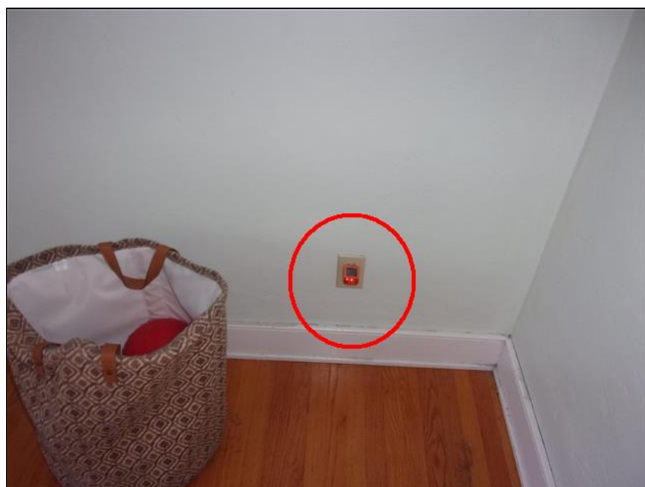
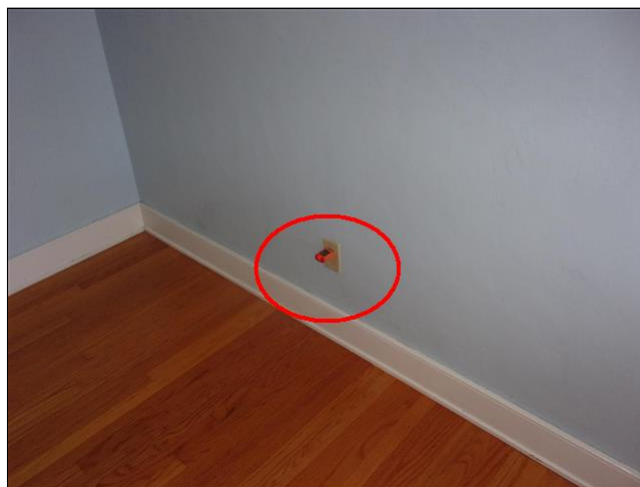
(2) Reversed polarity was observed at one or more of the outlets. This occurs when the hot and neutral are improperly connected at one or more areas of the circuit wiring. It is recommended to have a licensed electrician evaluate and correct as needed.

7.6 Item 2(Picture) reversed polarity observed when outlet was tested

7.6 Item 3(Picture) reversed polarity observed when outlet was tested

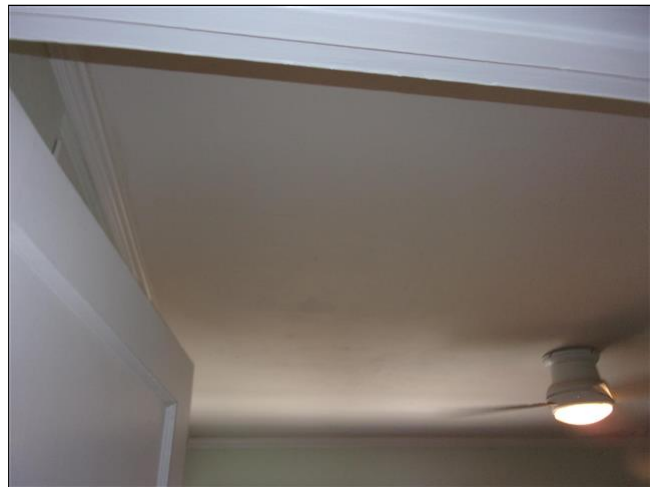
7.7 Item 3(Picture) missing bedroom smoke detector

If there is no visible installation date or the age cannot be verified, it is recommended to install a new detector with a visible date to facilitate future replacement. It is recommended to test detectors according to the manufacturers specifications. Consult with the local fire department for tips and other useful information on smoke alarm installation and maintenance.

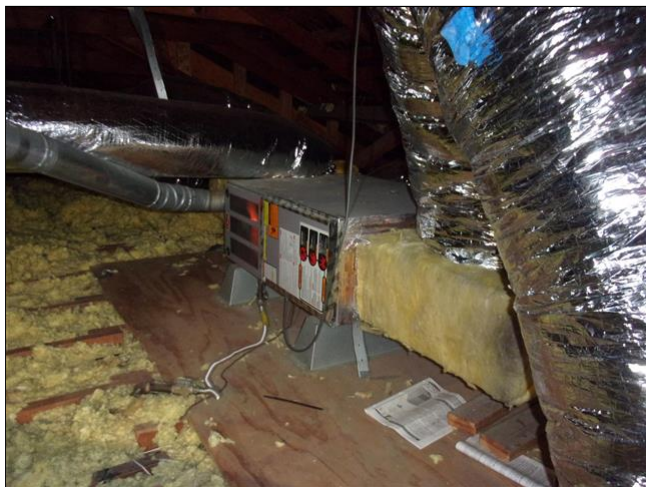
(1) Because no current visible maintenance or service record was observed, a performance and safety inspection by a licensed HVAC technician is recommended. An annual inspection by a technician can report any defects outside the scope of this inspection and provide an estimated life expectancy for the system and components.

8.2 Item 1(Picture) attic FAU: no visible maintenance record observed

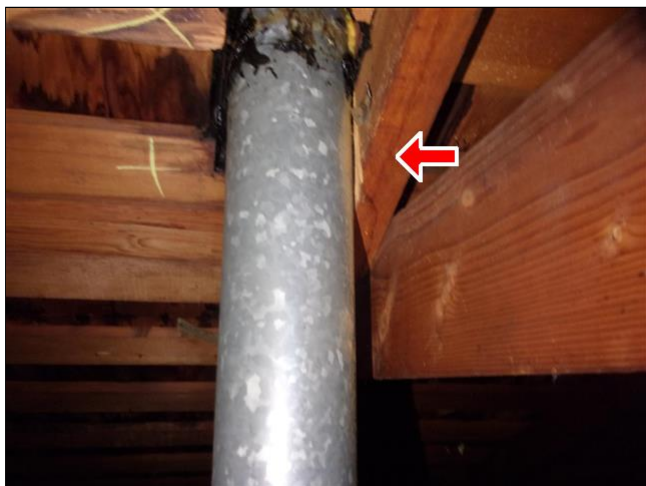
(2) The forced air unit (FAU) or furnace did not operate properly when tested or had other observable defect. It is recommended to have a licensed HVAC contractor for evaluate and repair/replace as needed.

8.2 Item 2(Picture) FAU gas vent is in contact with combustible wood (2" minimum separation needed)

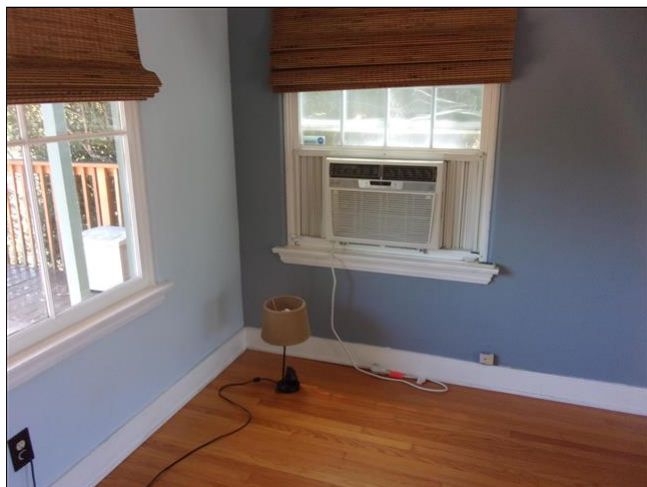
(2) Note: Window A/C units are not inspected or tested as part of the scope of this inspection.

8.4 Item 1(Picture) window a/c units were not inspected or tested as part of the scope of this inspection

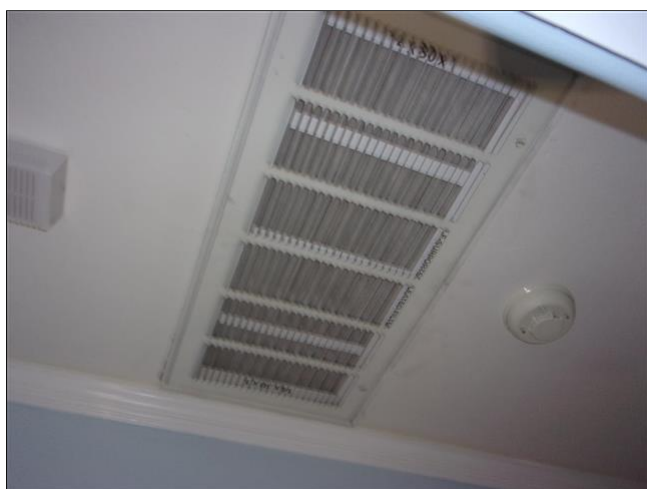
One or more of the return air filters are missing, damaged, or dirty and should be cleaned or replaced. Filters should be cleaned/replaced at least two times a year depending on usage.

8.7 Item 1(Picture) air filter replacement recommended

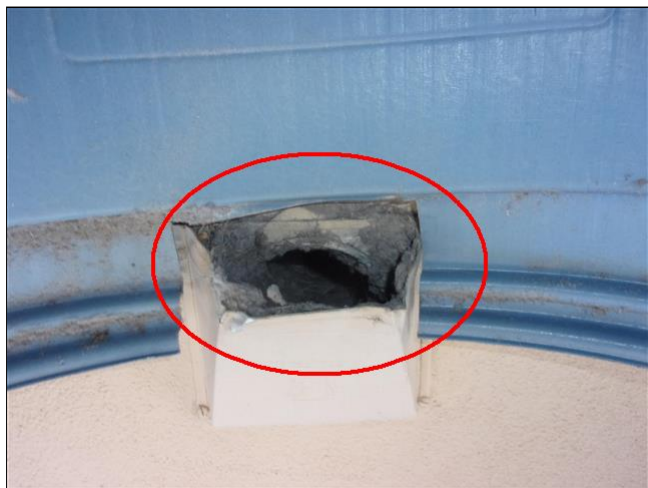
9.1 Item 1(Picture) dryer vent cleaning / maintenance/ repairs needed
