WOOD DESTROYING PESTS AND ORGANISMS INSPECTION REPORT

29TH ST, SAN DIEGO CA 92104

410975

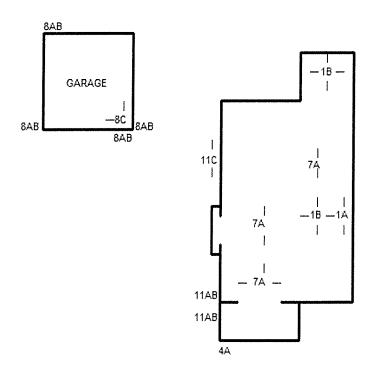
DIAGRAM IS NOT TO SCALE

ITEM 4A FINDING: FUNGUS has damaged the PILLAR SIDING and/or TRIM BOARDS, as indicated on the diagram.

ITEM 8B FINDING: DRYWOOD TERMITES have damaged the GARAGE EAVES/SOFFIT, as indicated on the diagram.

ITEM 11B FINDING: DRYWOOD TERMITES have damaged the EAVES, as indicated on the diagram.

ITEM 11C **FINDING: FUNGUS** have damaged the **ROOF SHEATHING**, as indicated on the diagram.

RECOMMENDATION: Remove the damaged wood for **FURTHER INSPECTION**. If no further damage is exposed, replace with new materials. Prime paint only.

RECOMMENDATION: Remove, repair, or reinforce the damaged WOOD as needed. Knight will prime paint only.
