Homescape Inspections

Report #: LAJ 10-18-22 Inspector: Kevin Brenden

Date of Inspection: 10/18/2022

Dwelling Address: 79 Port of Spain
Coronado, CA 92118

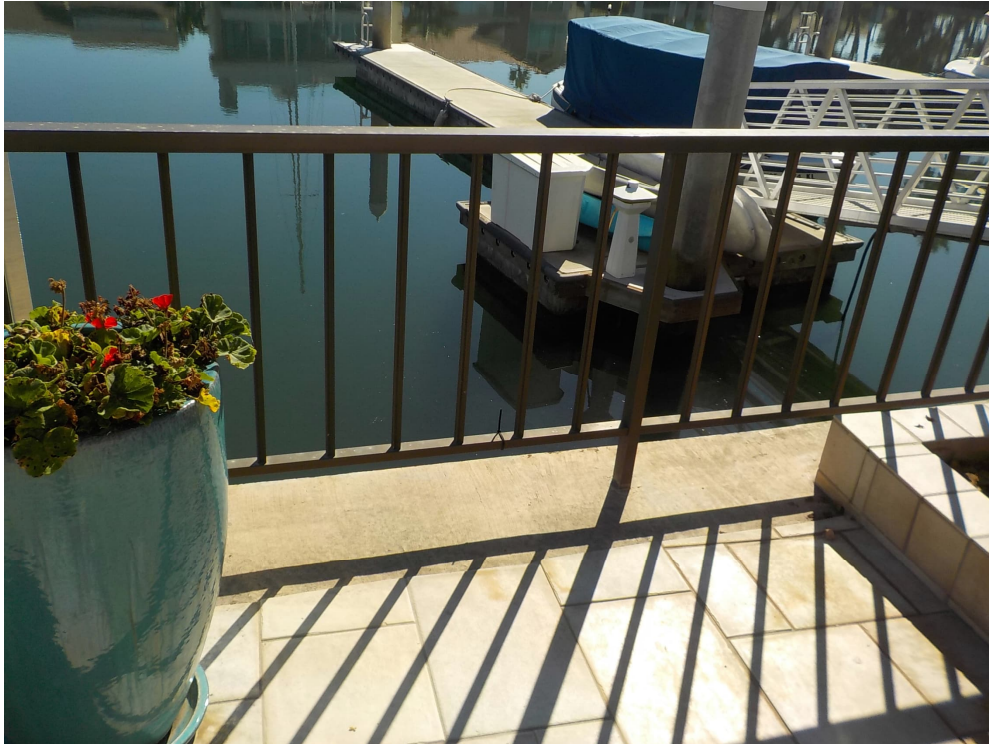
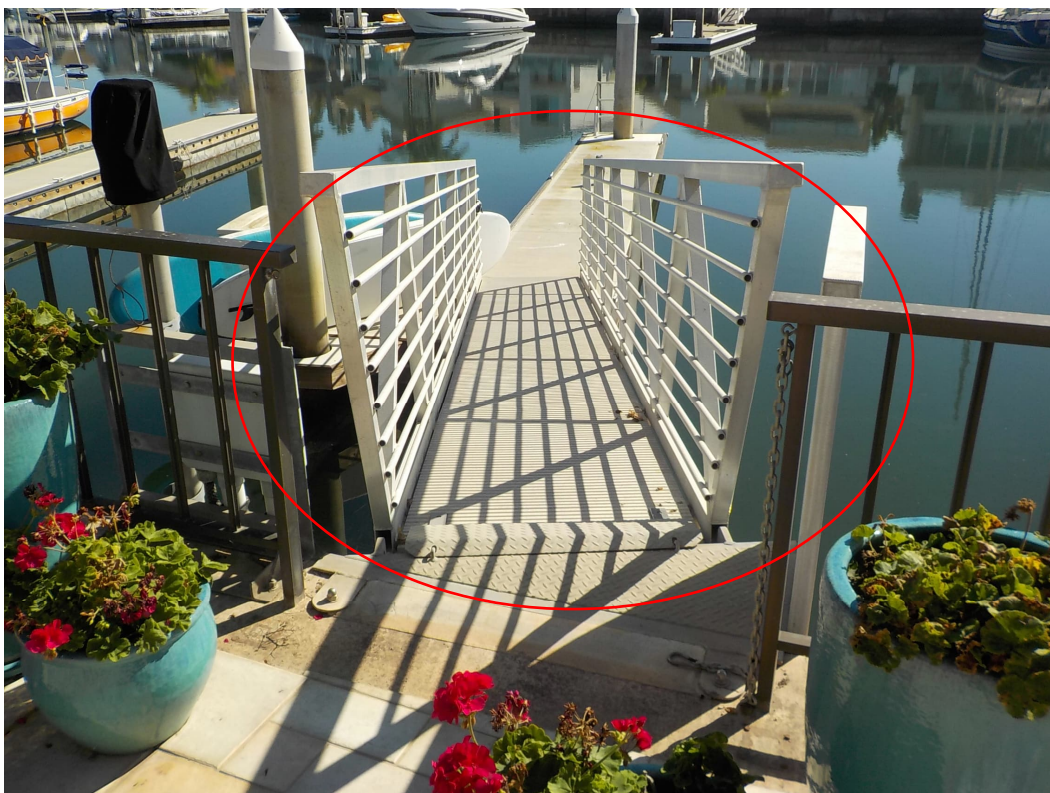
04

Repairs Recommended. Location(s):+Rear of home; Material:+Waterproof coating; Railing:+deteriorated (2) (4). Recommend further evaluation and repairs as needed by a qualified professional. (2)

Railings are in need of repairs. (2)

Moisture damage noted to wood framing for railing at time of inspection. (2) (3)

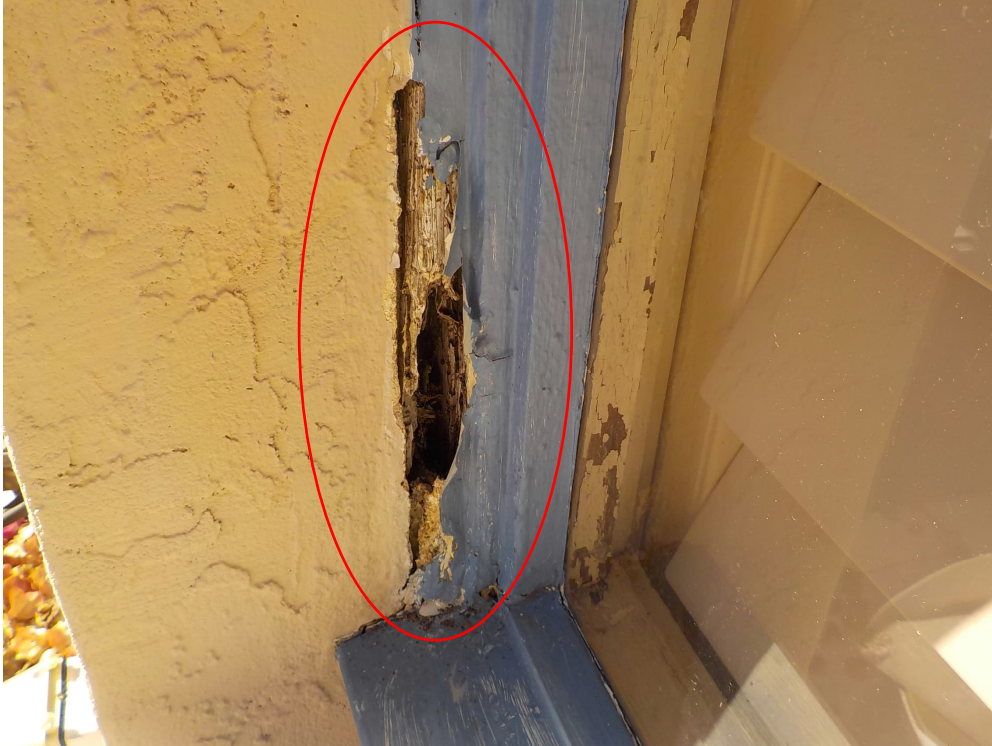
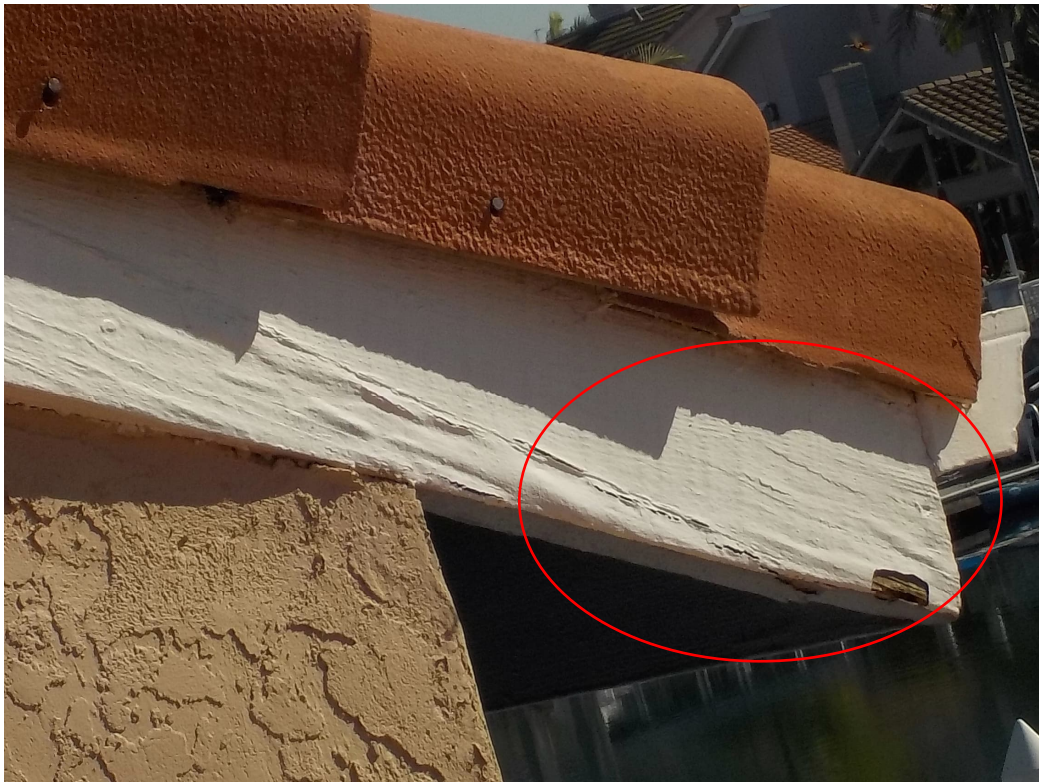
Step #	Component	Comments
09	Exterior Walls	Inspected-Appears Serviceable. Structure:+Wood Frame; Wall Covering:+Stucco.
10	Trim	<p>Repairs Recommended. Material:+Wood. Recommend further evaluation and repairs of trim as needed by a qualified professional. (2)</p> <p>Maintenance - Gaps were noted at wood seams and transitions from stucco to wood. Gaps in exterior siding or trim should be sealed/protected to help prevent water infiltration and moisture damage. (2)</p> <p>Deteriorated wood at fascia, window, eaves. (2) (3)</p> <p>We also recommend referring to the pest control report for their recommendations for repair as well as exact location of any damage caused by insects or dry rot. *</p>

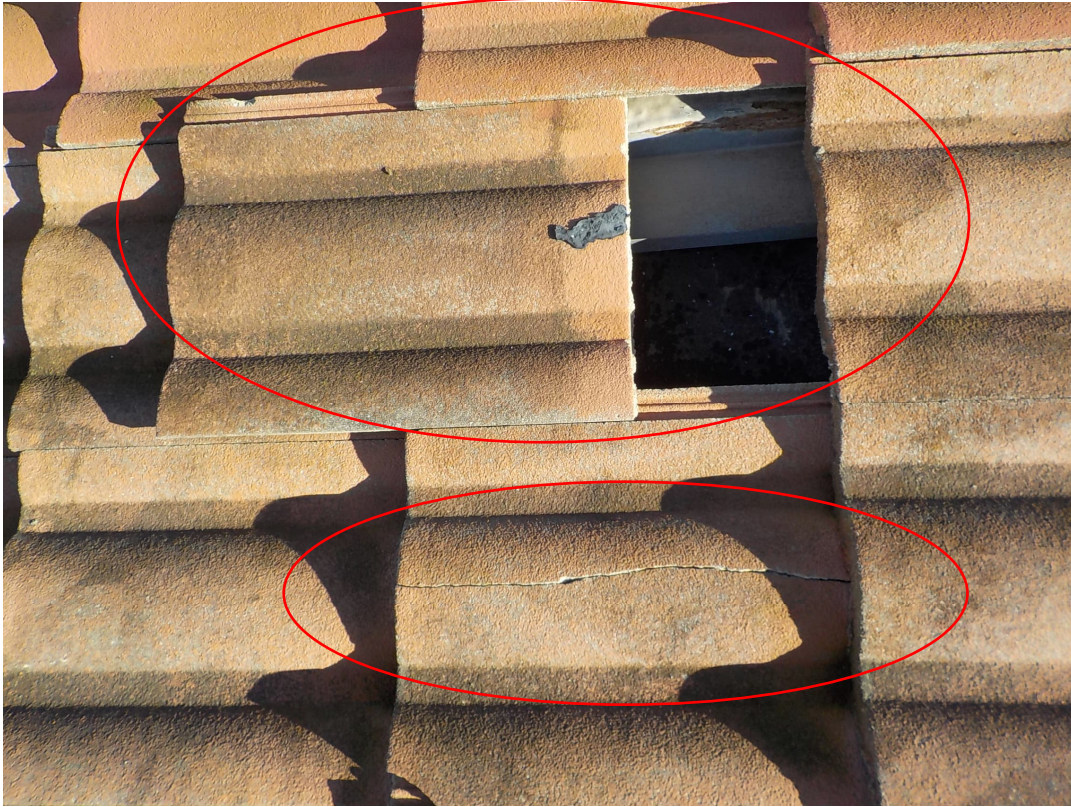
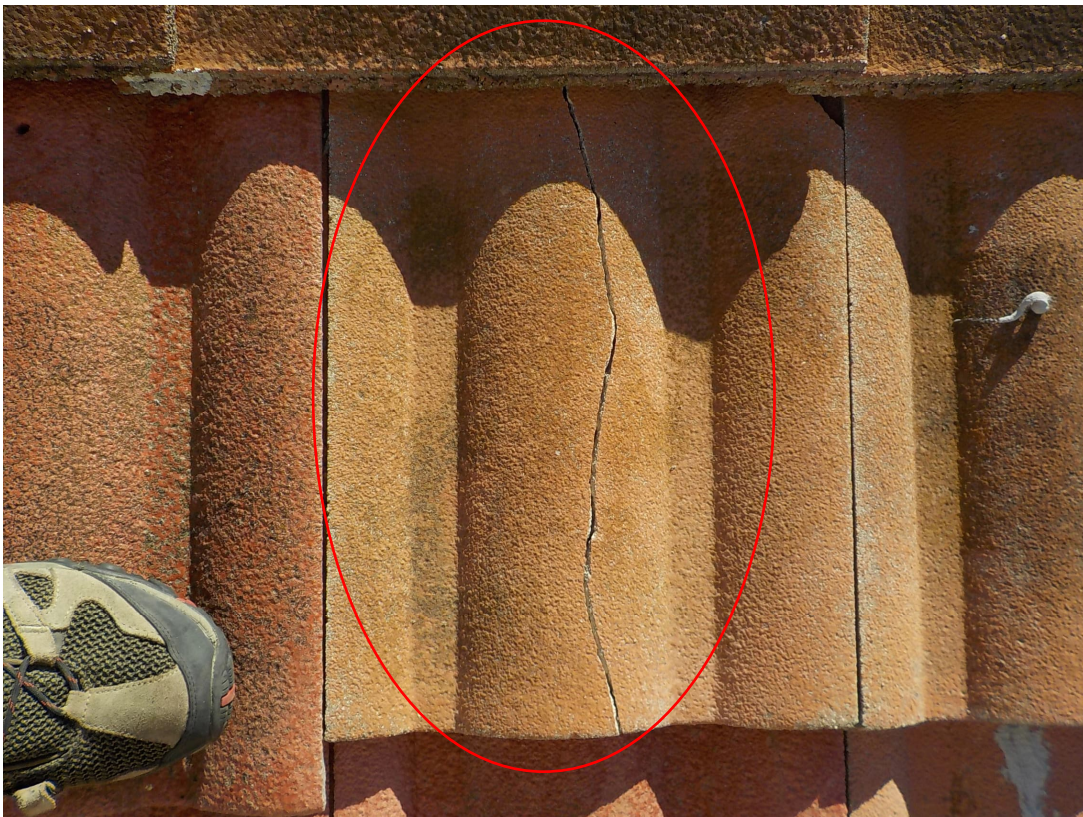
20a Tile Roof #2 **Repairs Recommended. Location:+Garage; Roof style:+Single Slope; Roof covering is:+concrete tile; Roof inspected by:+walking roof. Recommend further evaluation of roofing system and repairs by a qualified licensed roofing contractor. (2)**

The roofing underlayment appears to be In excess of 30 years old at the time of inspection. Licensed roofing contractors recommend removing tile and replacing the underlayment every 30 years at the most. The underlayment will become old and brittle after 30 years and no longer provide the water proofing that is recommended. (2)

Moss covering portions of the roof; this condition can accelerate the wear and deterioration of the roof. (2)

The roof covering had cracked tiles at the time of the inspection. (2)

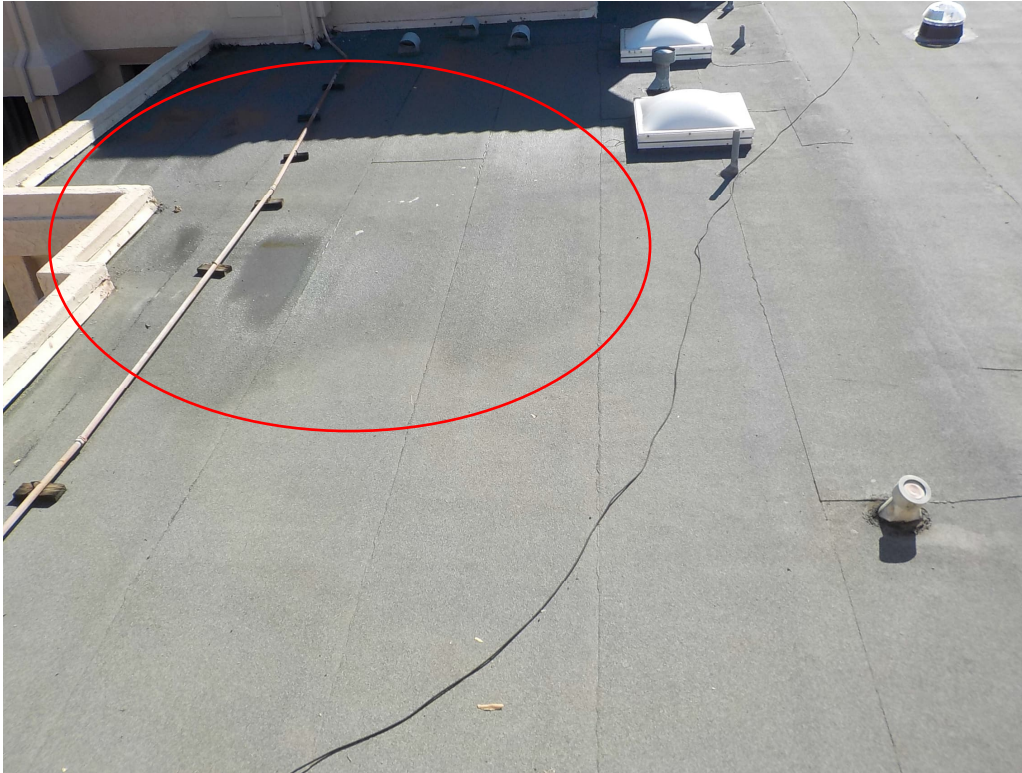
21	Built-up / Low slope	<p>Repairs Recommended. Location:+House; Roof style:+Low slope; Roof covering is:+rolled composition; Roof inspected by:+walking roof. Recommend further evaluation of roofing system and repairs by a qualified licensed roofing contractor. (2)</p> <p>Patching Noted: There are some areas of the roof that have been patched. This is noted for your information. We are not able to determine at the time f the inspection if the roof leaks at these areas. This is noted for your information, and is a disclaimer. It is always recommended that a licensed roofing contractor be called out for further evaluation if the repairs cannot be verified as being done by a licensed roofing contractor.</p> <p>There was evidence of poor drainage/pooling noted on the roof at the time of inspection.(2)</p> <p>Typical maintenance is recommended which generally consists of sealing penetrations, and repair or replacement of deteriorated or damaged materials. Maintenance should help to promote the water tightness of the building and should be performed on a regular basis.</p>

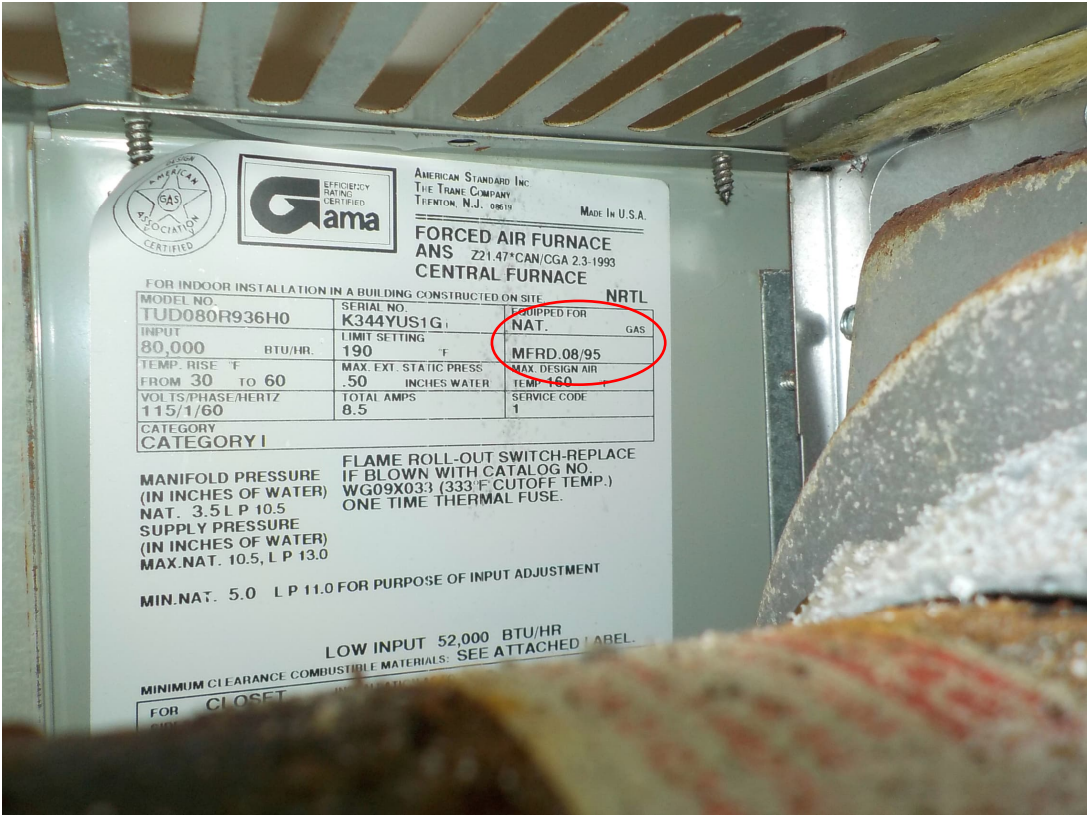
System is old and nearing, or is at the end of, its useful lifespan. Older systems are less efficient and subject to failure. Determining the future performance of the system is beyond the scope of this inspection. System could require repairs and/or replacement at any time. (2)

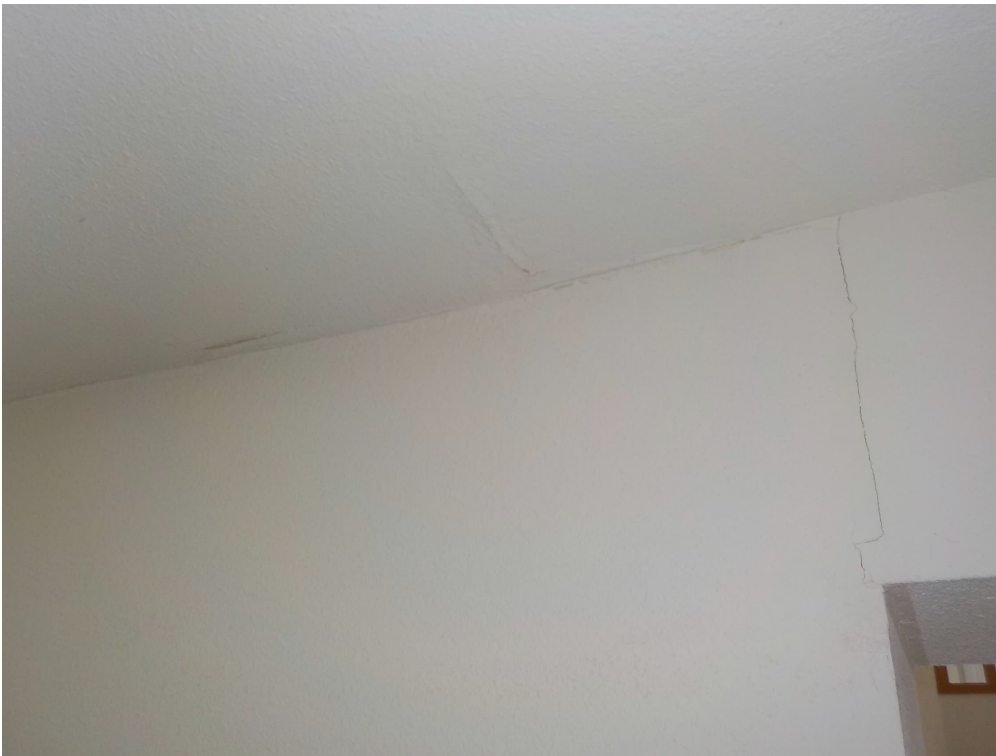
- 50 Ceilings **Repairs Recommended. Drywall. Recommend further evaluation and repairs as needed. (2)**

Moisture stains noted at exercise room. (2) (3)

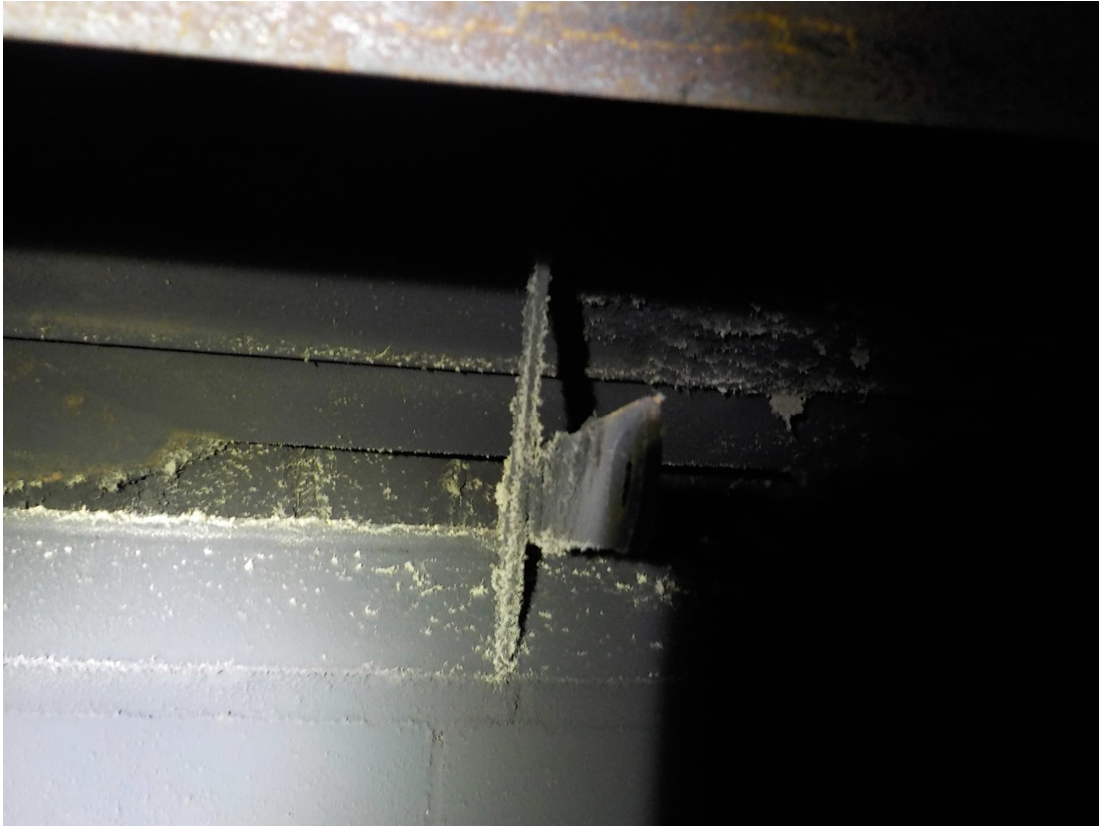
52	Fireplace(s)	<p>Safety Hazard. Location:+family room; Type:+Masonry - lined; Gas piping:+appears serviceable; Gas valve:+appears serviceable. Recommend further evaluation and repairs by a qualified professional. (4)</p> <p>There is no damper clamp or other mechanism to keep damper from closing fully as required with gas log assembly. * A damper clamp is required when there is a gas supply to the fireplace(s). This damper clamp prevents the damper from closing all the way as a safety precaution. If the damper is closed, Carbon Monoxide gas can enter the living space which is undetectable. SDG&E now requires damper clamps at all fireplaces. We recommend installation of a damper clamp.(4)</p> <p>Fireplace operated as designed at the time of inspection.</p>
----	--------------	---

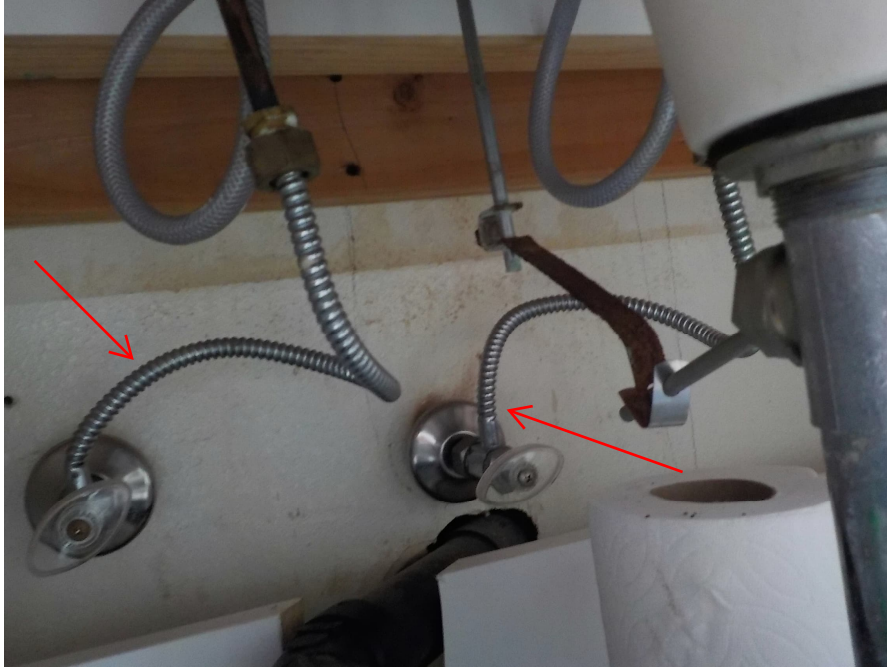
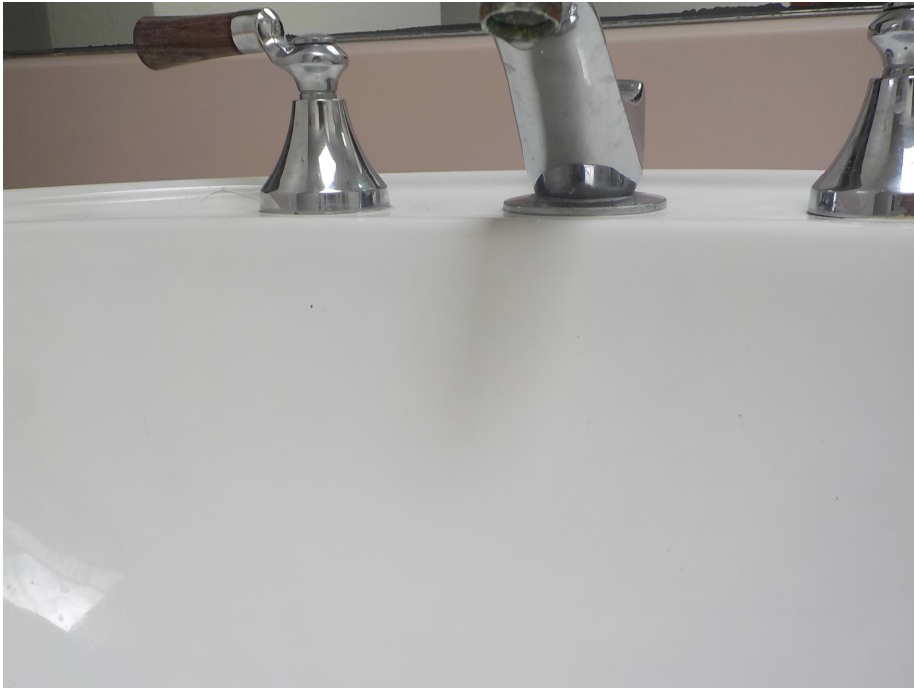
Step #	Component	Comments
72	Toilet	<p>Repairs Recommended. Recommend further evaluation by a qualified professional (Licensed Plumber). (2)</p> <p>The toilet is loose at the floor in lower bathroom. * (3)</p> <p>The inspector recommends a new wax seal in lower bathroom. (2)</p>
73	Sink	<p>Repairs Recommended. Counter & Cabinet appear serviceable. Recommend further evaluation by a qualified professional (Licensed Plumber). (2)</p> <p>One piece valve/flexible supply lines are installed at bathroom sink. These shut valves and supply lines are known to fail as a result of internal corrosion and hard water build-up. I recommend replacing all of these older angle stop valves with new valves and braided steel supply lines to avoid failure and reduced flow.</p> <p>The bathroom sink faucet leaks. (2)*</p>

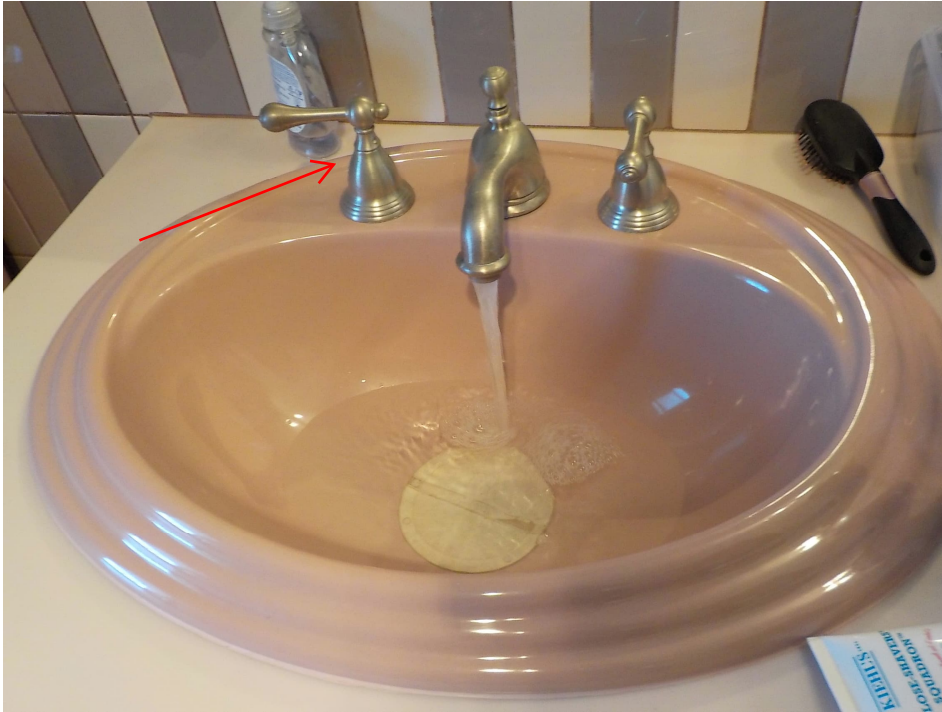
73.2a	Sink #2	<p>Repairs Recommended. Plumbing under sink appears serviceable; Counter & Cabinet appear serviceable. Recommend further evaluation by a qualified professional (Licensed Plumber). (2)</p> <p>The bathroom sink(s) faucet is not working properly, hot water valve was not operational. *</p> <p>Numerous items were stored under bathroom sink(s) preventing access for inspection. Recommend items be removed and area inspected prior to the end of the contingency period.</p>
