PROPERTY LOCATION
3704 Robinson Place, San Diego CA 92103

WOOD DESTROYING PESTS AND ORGANISMS INSPECTION REPORT

BUILDING NO. 3704	STREET, CITY, STATE, ZIP Robinson Place, San Diego CA 92103	Date of Inspection 4/29/2022	No. of Pages 7
  Termite and Pest Control (619) 462-5577 (619) 462-1700 Fax 3638 Bancroft Drive Spring Valley, CA 91977 www.d-and-s-termite.com			
Firm Registration No. PR 1164	Report No. 420906	Escrow No.	
Ordered By: Compass 8889 Rio San Diego Drive Ste 200 San Diego, CA 92108 Attn: Sabine Steck	Property Owner/Party of Interest Julio Garcia Coop 3704 Robinson Place San Diego, CA 92103	Report Sent To: Compass 8889 Rio San Diego Drive Ste 200 San Diego, CA 92108 Attn: Sabine Steck	
COMPLETE REPORT <input checked="" type="checkbox"/> LIMITED REPORT <input type="checkbox"/>		SUPPLEMENTAL REPORT <input type="checkbox"/> REINSPECTION REPORT <input type="checkbox"/>	
General Description: 1-2 story, single family residence, frame and stucco construction, flat and tile roof		Inspection Tag Posted: Sub Area

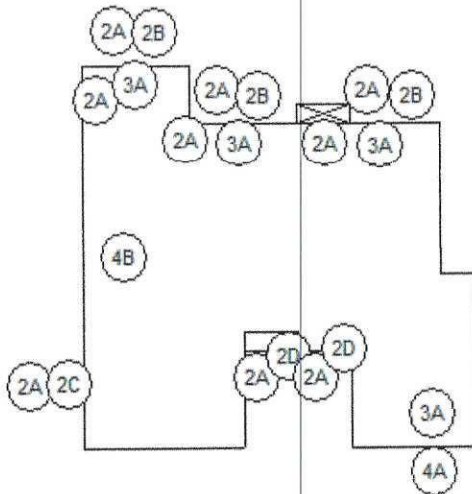
Diagram not to scale, findings in approximate locations.

FINDING: Evidence of drywood termites noted in exposed wood members of residence, see 2A on diagram.

FINDING: Evidence of drywood termite damage noted in door sills / thresholds, and door jambs of residence, see 2B on diagram.

FINDING: Evidence of drywood termite damage noted in window sills / frames of residence, see 2C on diagram.

FINDING: Evidence of drywood termite damage noted in beam tails of residence, see 2D on diagram.

FINDING: Fungus damage noted in door sills / thresholds, and door jambs of residence, see 3A on diagram.

FINDING: Moisture damage noted in door nex to refrigerator of residence, see 4A on diagram.

FINDING: Cracked shower enclosure tiles of residence, see 4B on diagram.

RECOMMENDATION: Fumigate entire structure with lethal fumigant Sulfuryl Fluoride (VIKANE) Introduce Chloropicrin (tear gas) as needed as a warning agent. Fumigation will assure complete elimination of drywood termites, cover or clean up all visible and accessible pellets as needed. Fumigation notice and pesticide disclosure MUST be read and signed prior to injection of fumigant. Fumigation guaranteed for two years. **ALL FUMIGATIONS CANCELED LESS THAN 72 HOURS PRIOR TO SCHEDULED DATE WILL BE SUBJECT TO A CANCELLATION FEE OF 25% OF THE FUMIGATION COST.**

RECOMMENDATION: Remove and replace or repair drywood termite damage as needed. Work completed by D&S Termite guaranteed for one year. If certification is required D&S Termite must re inspect work completed by others. D&S Termite does not guarantee work completed by others. D&S Termite & Pest Control will apply primer coat, but cannot be responsible for match of color. If during the course of repair work, fungus and/or termite damage extends into inaccessible areas, there may be an additional charge for repairs. D&S Termite & Pest Control will contact you about additional charges if any.

RECOMMENDATION: Remove and replace or repair fungus damaged wood as needed. Work completed by D&S Termite guaranteed for one year. If certification is required D&S Termite must re inspect work completed by others. D&S Termite does not guarantee work completed by others. D&S Termite & Pest Control will apply primer coat, but cannot be responsible for match of color. If during the course of repair work, fungus and/or termite damage extends into inaccessible areas, there may be an additional charge for repairs. D&S Termite & Pest Control will contact you about additional charges if any.

RECOMMENDATION: Remove and replace or repair moisture damaged wood as needed. Work completed by D&S Termite guaranteed for one year. If certification is required D&S Termite must re inspect work completed by others. D&S Termite does not guarantee work completed by others. D&S Termite & Pest Control will apply primer coat, but cannot be responsible for match of color. If during the course of repair work, fungus and/or termite damage extends into inaccessible areas, there may be an additional charge for repairs. D&S Termite & Pest Control will contact you about additional charges if any.

RECOMMENDATION: Owner to contact licensed contractor to inspect and repair as needed.
